**FINAL REPORT
GEOTECHNICAL INVESTIGATION
Marina Boulevard Seawall
San Francisco, California**

**City and County of San Francisco
San Francisco, California**

**12 December, 1997
Project No. 1526.02**

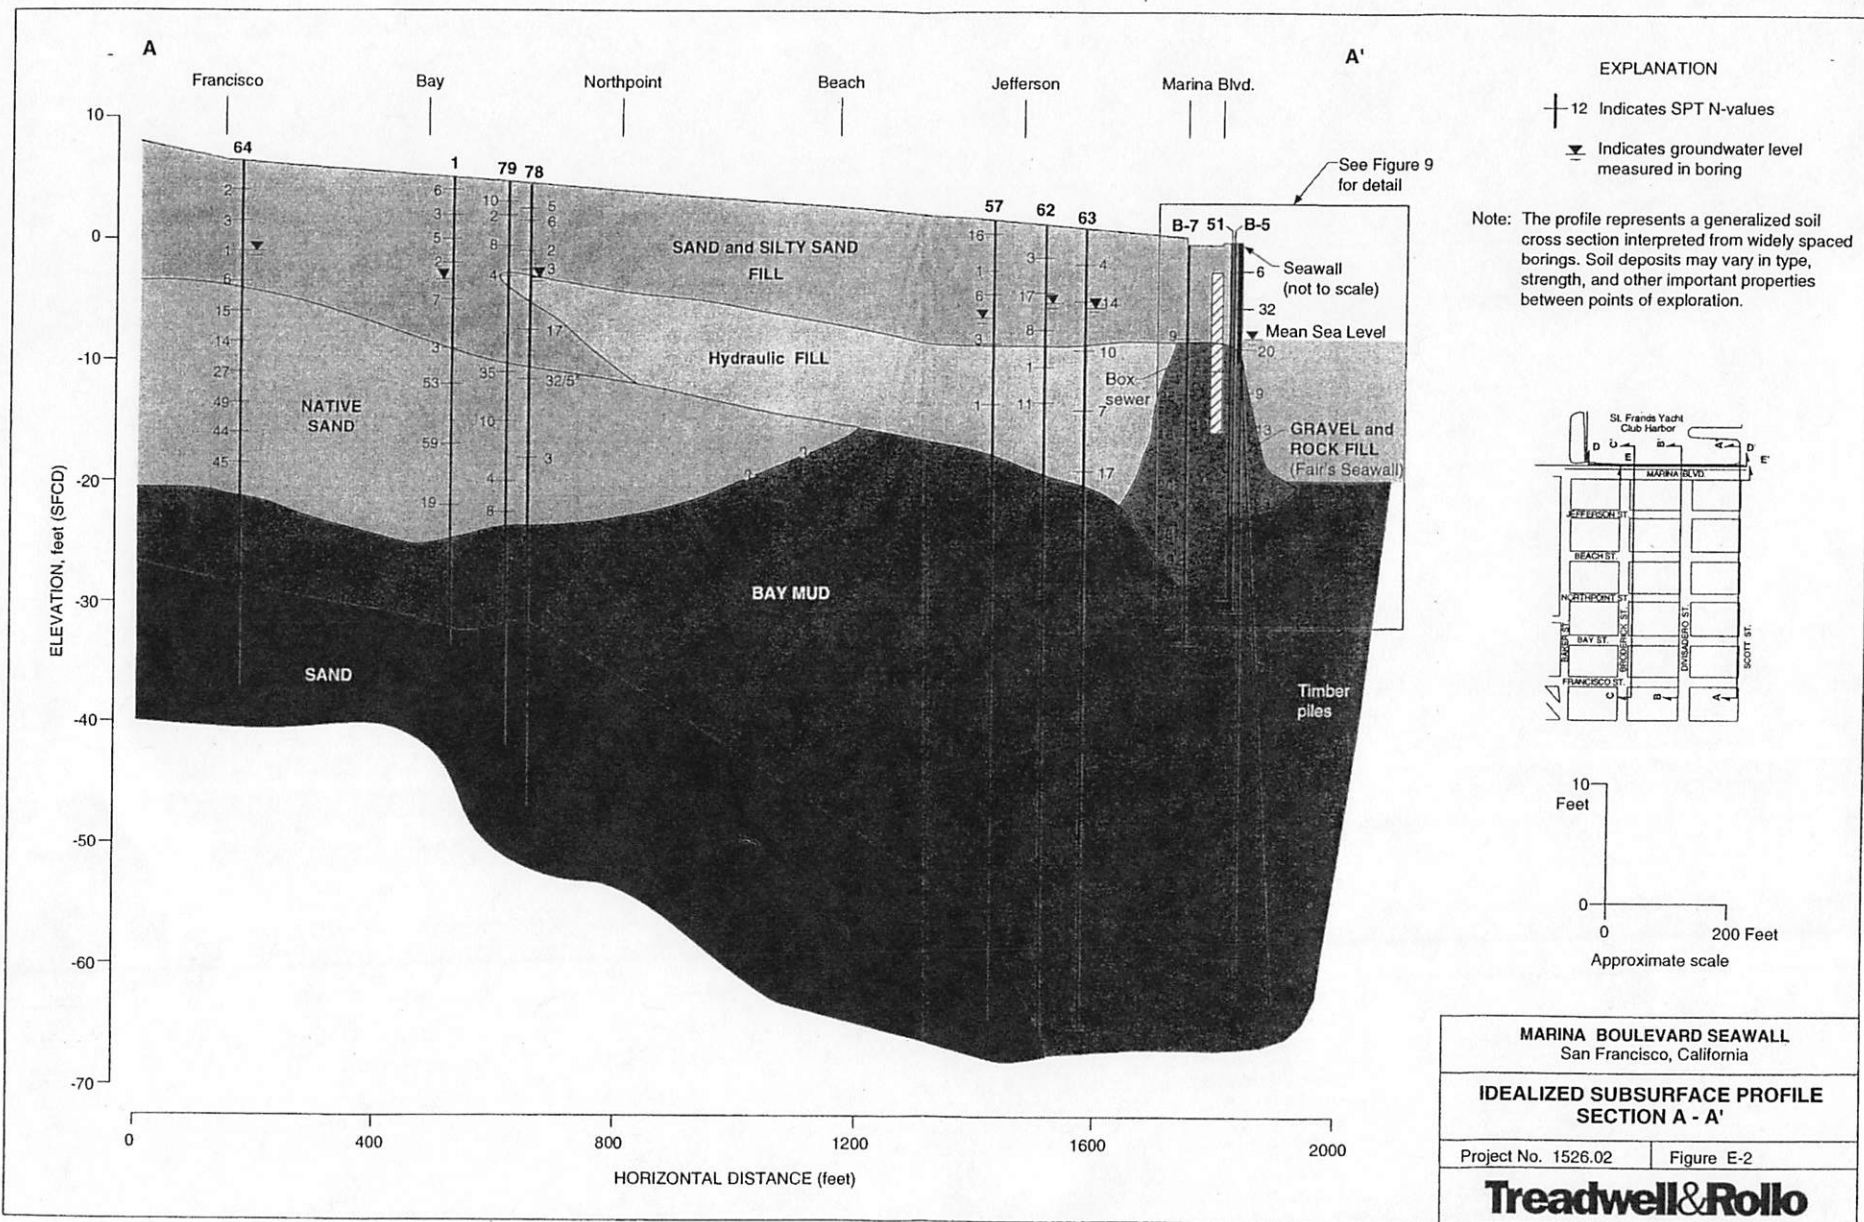
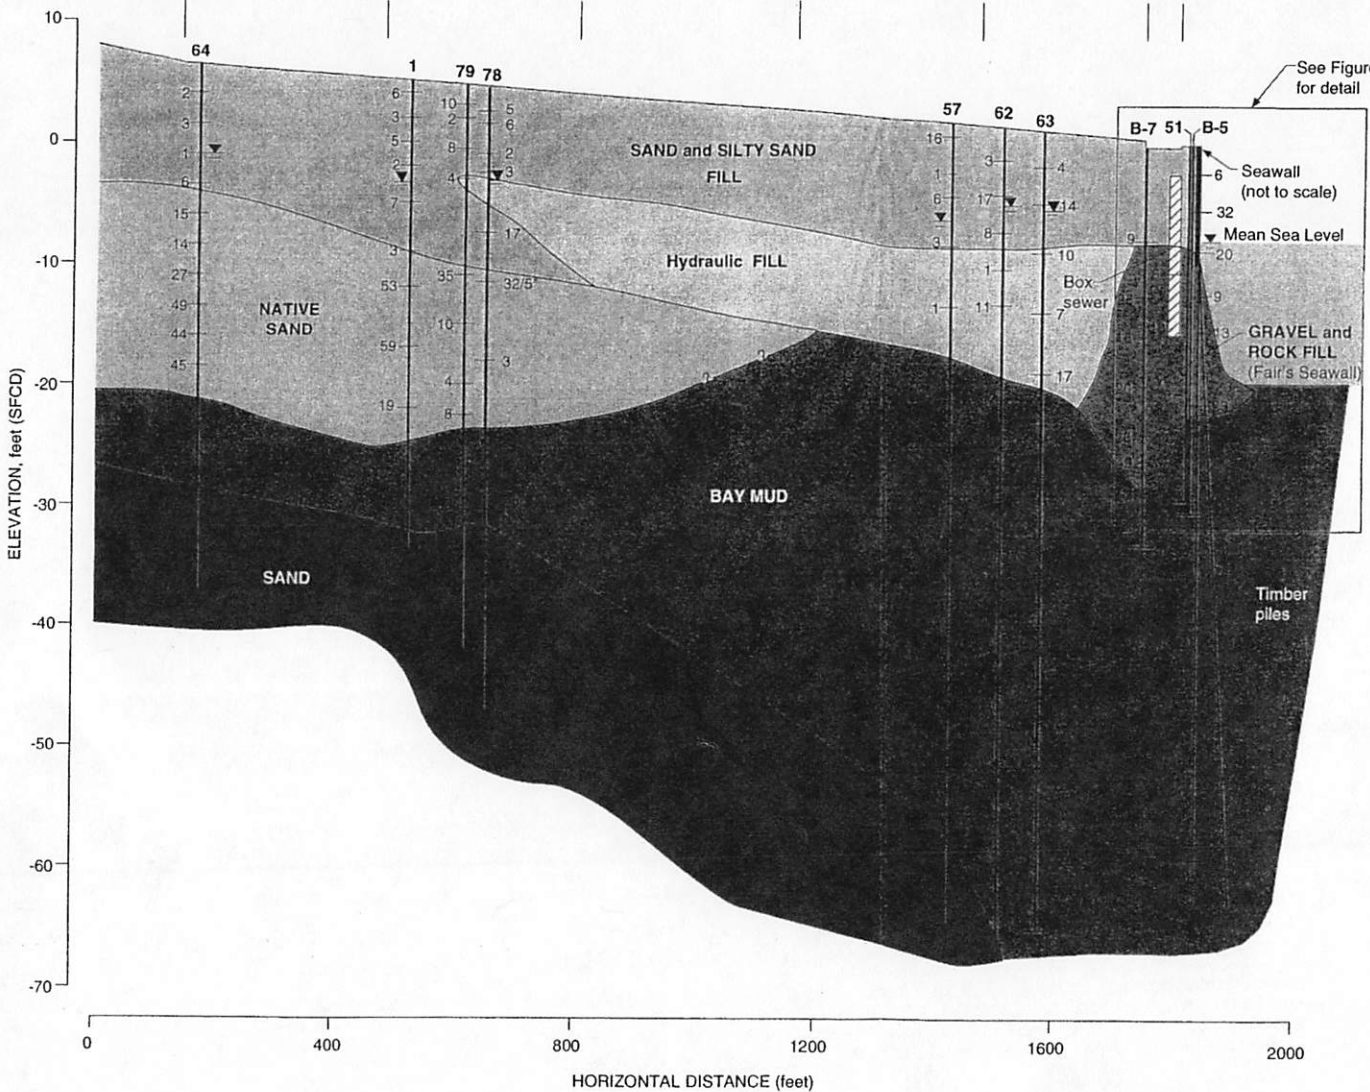
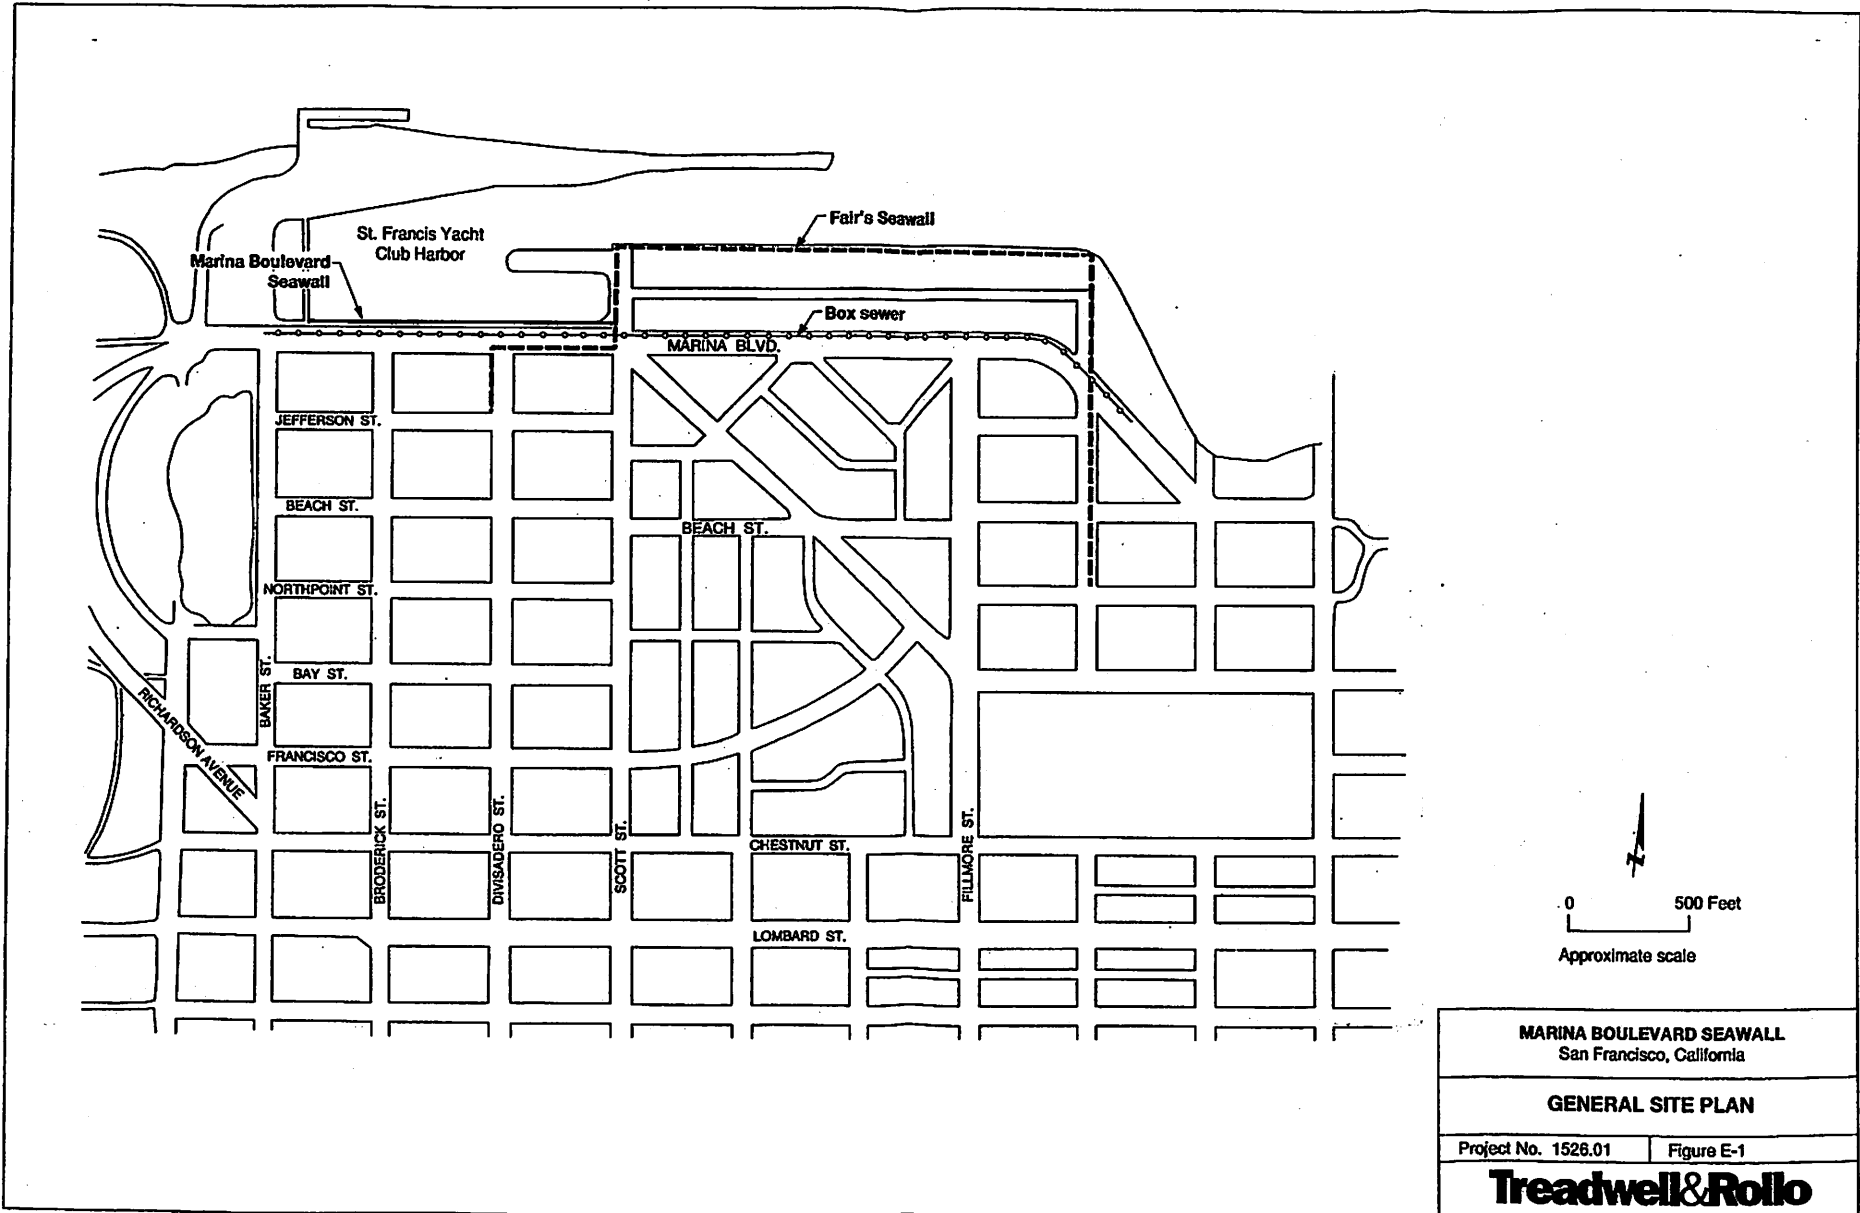
MARINA BOULEVARD SEAWALL San Francisco, California	
GENERAL SITE PLAN	
Project No. 1526.01	Figure E-1
Treadwell&Rollo

estimate the lateral movement would be about three feet for the magnitude 7.9 event and six inches for the magnitude 7.0 event. These movements would occur primarily east of Divisadero Street. Significant lateral spreading is not expected to occur west of Divisadero Street, where the soil below the water table primarily consists of medium-dense to dense natural sand (instead of fill).
