Experts' Response to July 11, 2016 Evidence Package
Prepared by: Stuart Siegel, Peter Baye, and Bruce Herbold
July 21, 2016

EXPERTS' RESPONSE TO JULY 11, 2016 EVIDENCE PACKAGE

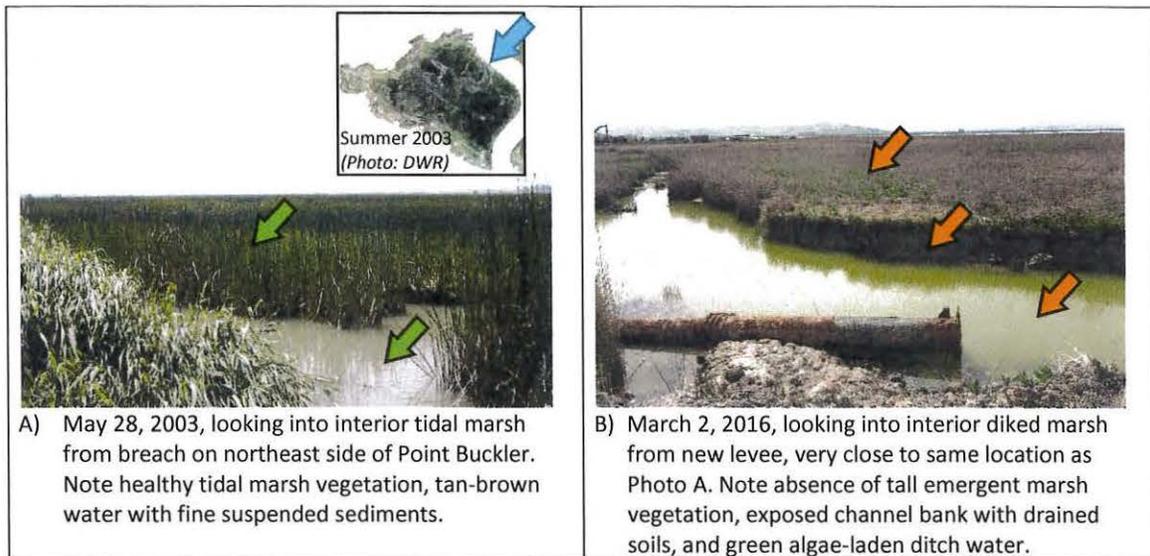
Photo 1. Comparison of Pre-Existing Tidal Marsh vs. Same Location After Diking and Draining

Photo sources: Stuart Siegel (A is Photo 1 in May 2016 Technical Assessment)

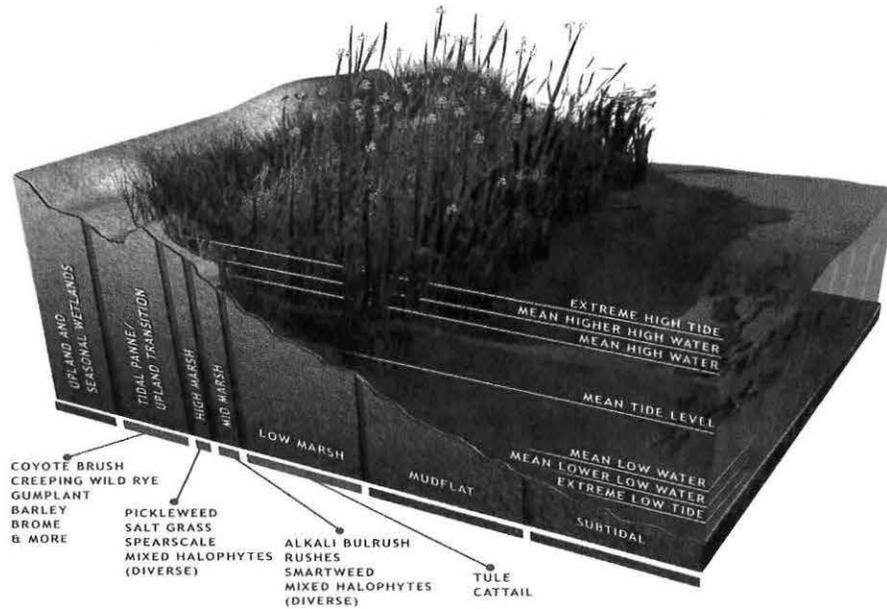
Figure 1. Typical Cross Section of a Brackish Tidal Marsh

Vegetated upper intertidal marsh plains such as those at Point Buckler do not have daily tidal flooding, but only periodic tidal flooding. Only low intertidal marshes below MHW flood daily or nearly so. Mature tidal marshes around the globe are found relatively high in the tidal frame where only some high tides reach (Figure 1). Tides have strong seasonal components to their heights, with the highest tides occurring around the winter and summer solstice. Winter tides tend to be higher in the San Francisco Estuary because of our Mediterranean winter-wet, summer-dry climate. Prolonged droughts like we have been experiencing since 2011 (coincident with Mr. Sweeney’s purchase of Point Buckler) further depress high tides due to reduced Delta outflow and high pressure ridges over California. In the intervals between these winter and summer “spring” tides, tidal marsh plains can be exposed for weeks or more at a time. Tidal marshes are 100% within State and federal regulatory jurisdiction. The Opposition Brief (pages 22-24), for the reasons stated above and as extensively evidenced by historical aerial photography (Appendix G of the May 2016 Technical Report), mistakenly asserts the interior was

dry land before the levee was repaired. Consequently, the entirety of the Discharger's arguments about lack of jurisdiction and what follows from it are incorrect.

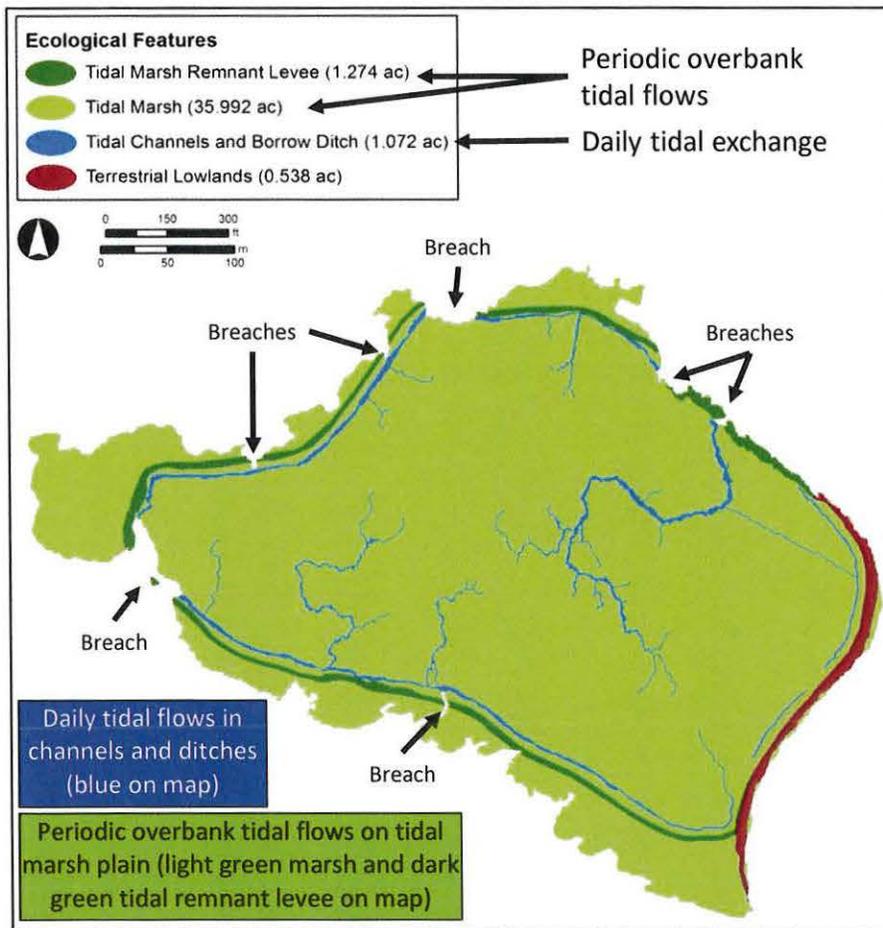
Figure 2. Daily and Periodic Tidal Exchange Geographic Extents, Baseline Conditions

Figure 2 shows the geographic extent of daily “in-channel” and periodic “overbank” tidal inundation. The overbank tides occur infrequently (as much as a few times a month to none for several months), these tides last briefly (anywhere from a few minutes up to 2-3 hours at the peak of the high tide event), and they are fairly shallow (from a few inches to less than 2 feet on the most extreme and rare high tides).

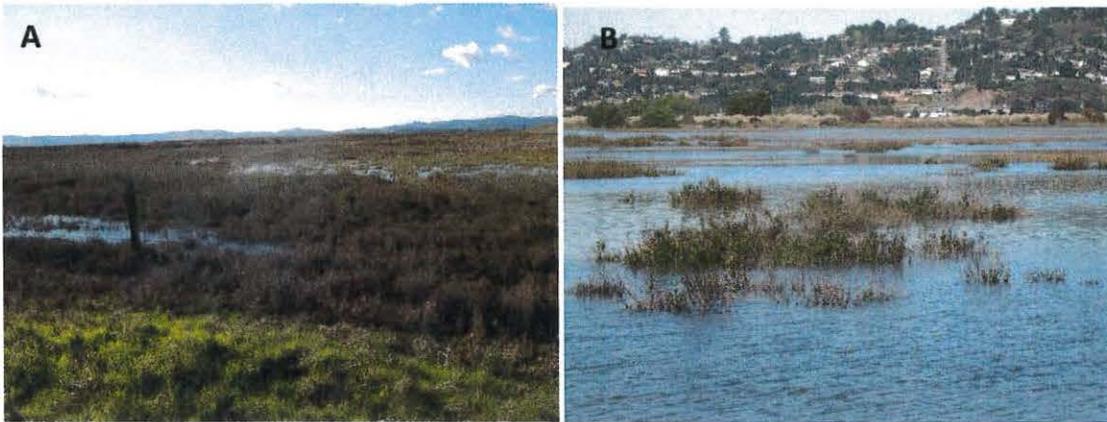
Photo 2. Overbank King High Tides at Rush Ranch, Suisun Marsh and Muzzi Marsh, Corte Madera

First, the brief and very shallow overbank inundation would have been hidden within the extensive cover of tall, dense vegetation. It is very conceivable that an equipment operator would not have noticed this inundation, especially if their attention was focused on equipment operations. In the brackish tidal marshes of Suisun, the tall, dense vegetation (cattails, bulrush, tules) generally obscures spring high tide water surfaces that rise above the marsh plain, tides impossible or very difficult to see (Photo 2A), except at locations of unvegetated gaps on the marsh plain or at the rare vegetation patches with prostrate, low vegetation types (Photo 2B).

Suisun Marsh brackish tidal marsh vegetation generally masks maximum winter “King” tides. Maximum “King” high tide (perigee spring high tide) at (A) tidal fresh-brackish marsh of Rush Ranch, Suisun Marsh and at (B) tidal salt marsh at Muzzi Marsh, San Francisco Bay, December 13, 2012. The same extreme high tide water surface overtops relatively short salt marsh vegetation at Muzzi Marsh (B), but is visible only over patches of low-growing saltgrass at Rush Ranch (A), where taller bulrushes, cattail, tules, and rushes form a canopy that covers the water surface.

The tide data of Figure 3 indicate that the tides reached the height for island inundation and we have established (Photo 2) that the type of tall vegetation on the island can readily obscure tidal inundation, thus Mr. Sweeney's observations cannot support his assertion that no inundation of the island occurred.

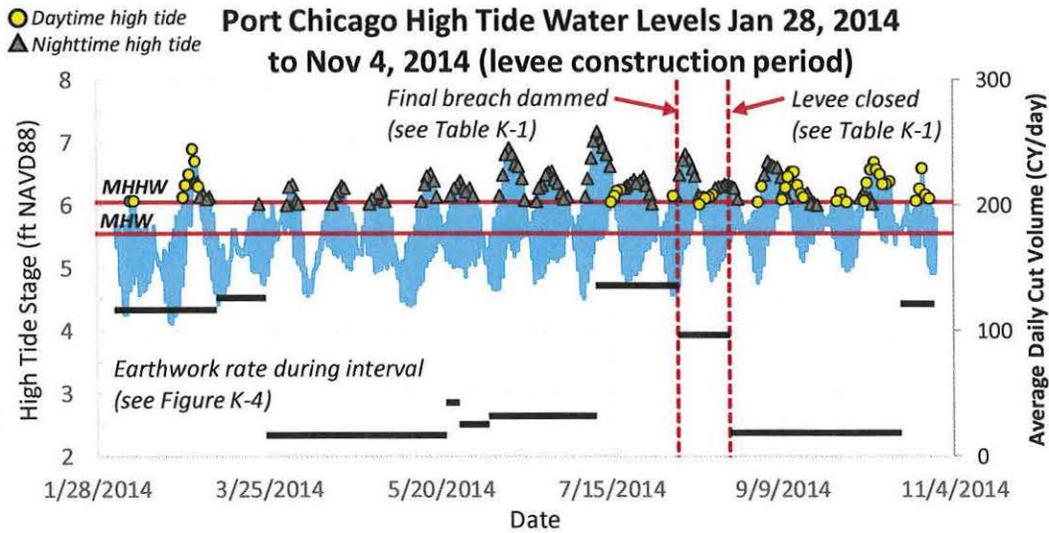
Figure 3. Day/Night Higher High Tide Occurrence and Earthwork Intensity during 2014 Levee Construction

Daily earthwork rate (solid black horizontal lines below tides), high tides >6 ft occurring during daylight (yellow circles) and during nighttime (grey triangles). Note that only six high tides >6ft occurred during the daytime hours during the early phase of levee construction.

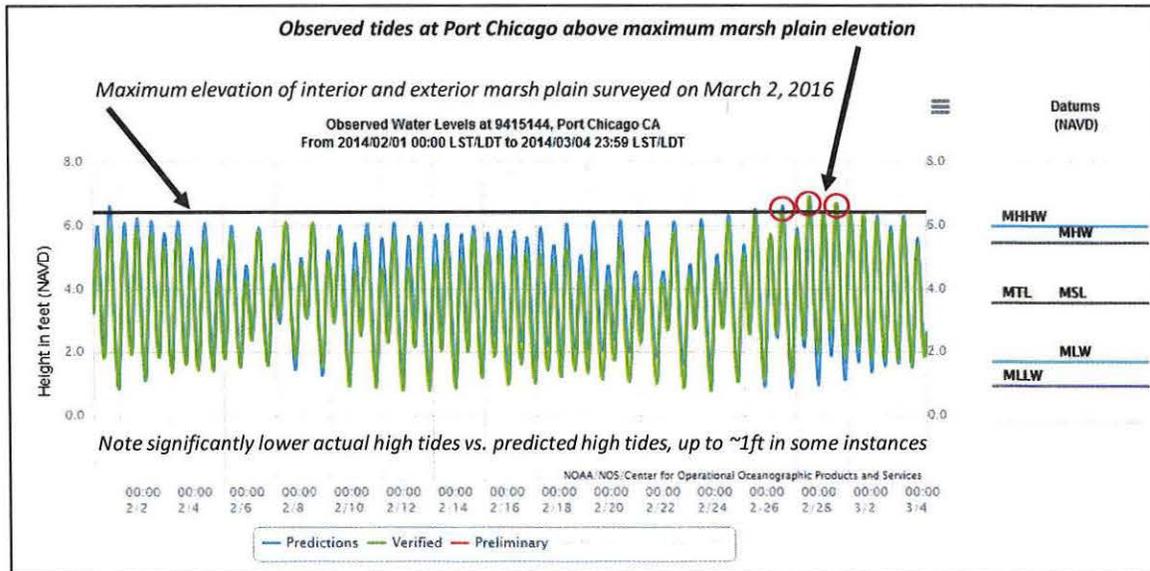
Figure 4. Predicted and Verified Port Chicago High Tides, February 1 to March 4, 2014

Third, during the February 2014 high tides, Mr. Sweeney worked atop the remnant 1985 levee. Construction equipment was thus sitting on comparatively firm ground (Figure 4). The high tide at Port Chicago reached only 0.46 ft at maximum above the marsh plain elevation during those February 2014 tides. The maximum length of time that water may have shallowly flooded the Point Buckler marsh was no more than 3 hours. The maximum depth of water would have lasted only very briefly at slack high tide (Figure 5). It is very possible that an equipment operator would not have noticed this inundation.

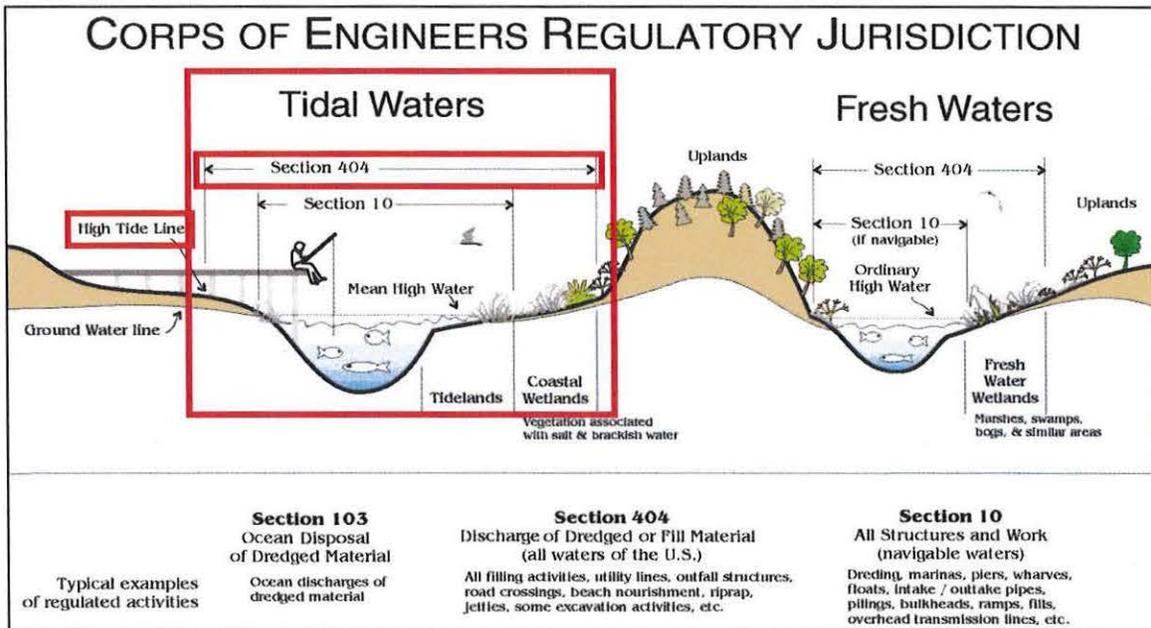
Figure 6. Corps of Engineers Jurisdiction Section 10 and Section 404

The definition of the High Tide Line in the Clean Water Act is found in 33 CFR Part 328.3(d) and its extent is illustrated in Figure 6:

The regulatory definition of High Tide Line expressly excludes irregular extreme storm-elevated rise in water levels, such as extreme storm wave run-up or storm surges.

The regulatory definition of High Tide Line does not expressly exclude calm-weather, non-storm high tides influenced by prolonged El Niño (ENSO) elevated sea level above predicted astronomic tides. ENSO events are not "storms", "storm surges" or "piling up of water against a coast by strong winds", but are recurrent (periodic) natural climate-driven hydrologic events affecting tidal heights. ENSO events were not scientifically known at the time HTL definition was made by rulemaking.

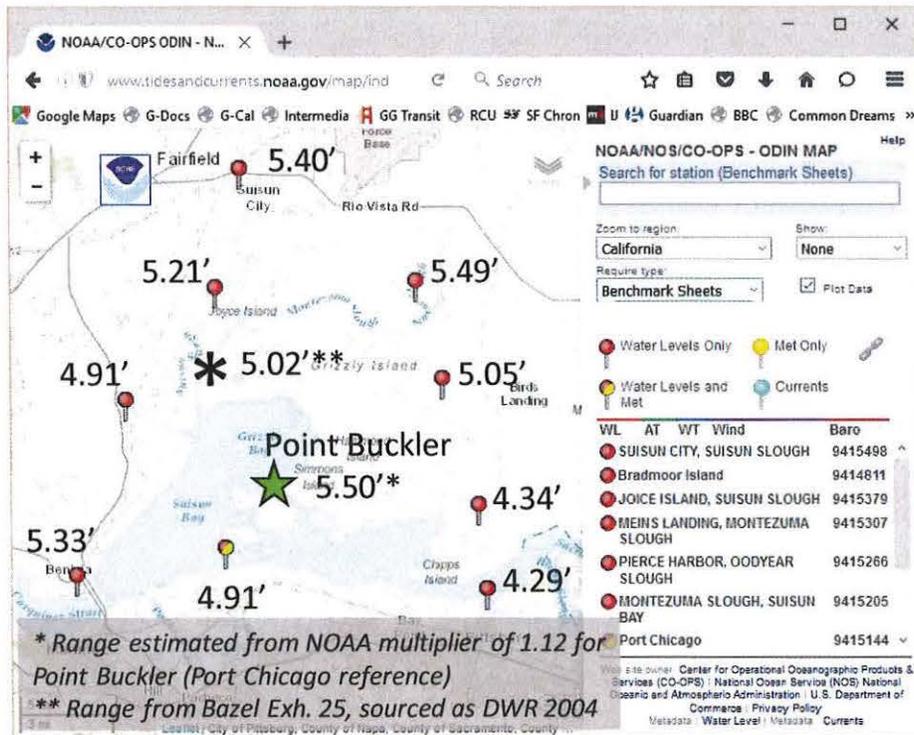
Figure 7. Tide Ranges at NOAA Stations Around Suisun Marsh

1. **Tides Ranges Around Most of Suisun Marsh Are Higher than at Port Chicago.** The Opposition Brief suggests that tides may be lower at Point Buckler than at Port Chicago (page 17 lines 13-16), and introduces a DWR station on Montezuma Slough at its intersection with Hunter’s Cut and a lower tide range is introduced as evidence. The national authority on the tides is NOAA, and Figure 7 illustrates variable tide ranges around Suisun Marsh. The Opposition Brief and the Bazel Declaration Exhibit 25 rely upon outdated DWR tide station data, and the range of the tides at that station (MLLW to MHHW) is in line with NOAA-reported tide ranges in the vicinity (Figure 7).

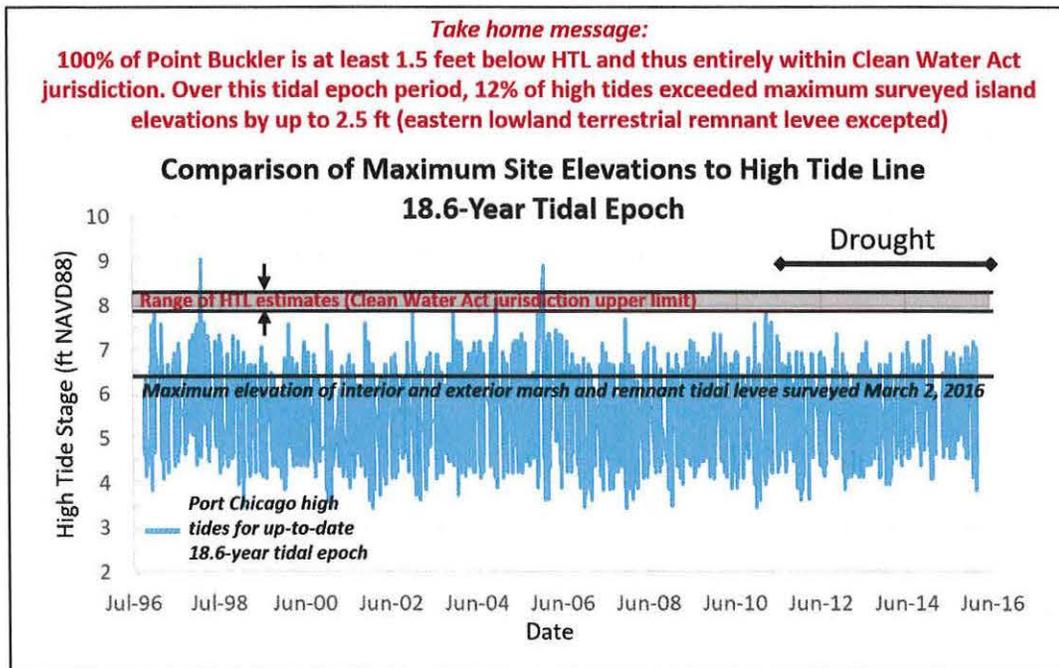
Figure 8. High Tides at Port Chicago 1996 to 2016, Maximum Ground Surface Elevations Surveyed at Point Buckler March 2, 2016, and Estimated High Tide Line at Point Buckler

The Opposition Brief (Section III, pages 14-20) carried the conflation of Corps jurisdictions into where and when tidal flows were at Point Buckler before new levees were built. The Dischargers reference “daily tidal flows” which occurred in all the tidal channels and ditches (Rivers and Harbors Act [RHA] and Clean Water Act [CWA] jurisdiction), and they reject or omit the “periodic tidal flows” (CWA jurisdiction) that are the higher high tides that reach high enough to flood the marsh plain. Over the past 20 years, corresponding to a full tidal epoch (see discussion of tides below), approximately 12% of the high tides at Port Chicago exceeded the marsh plain elevation interior and exterior to the new levees as surveyed on March 2, 2016 (Figure 8). Looking only during the time period in 2014 when Mr. Sweeney constructed the new levee (Figure 9), approximately 8% of the high tides exceeded the surveyed interior and exterior marsh plain elevation. This difference may be due to drought conditions preceding and beyond 2014 that have reduced high tide levels persistently (Figure 8).

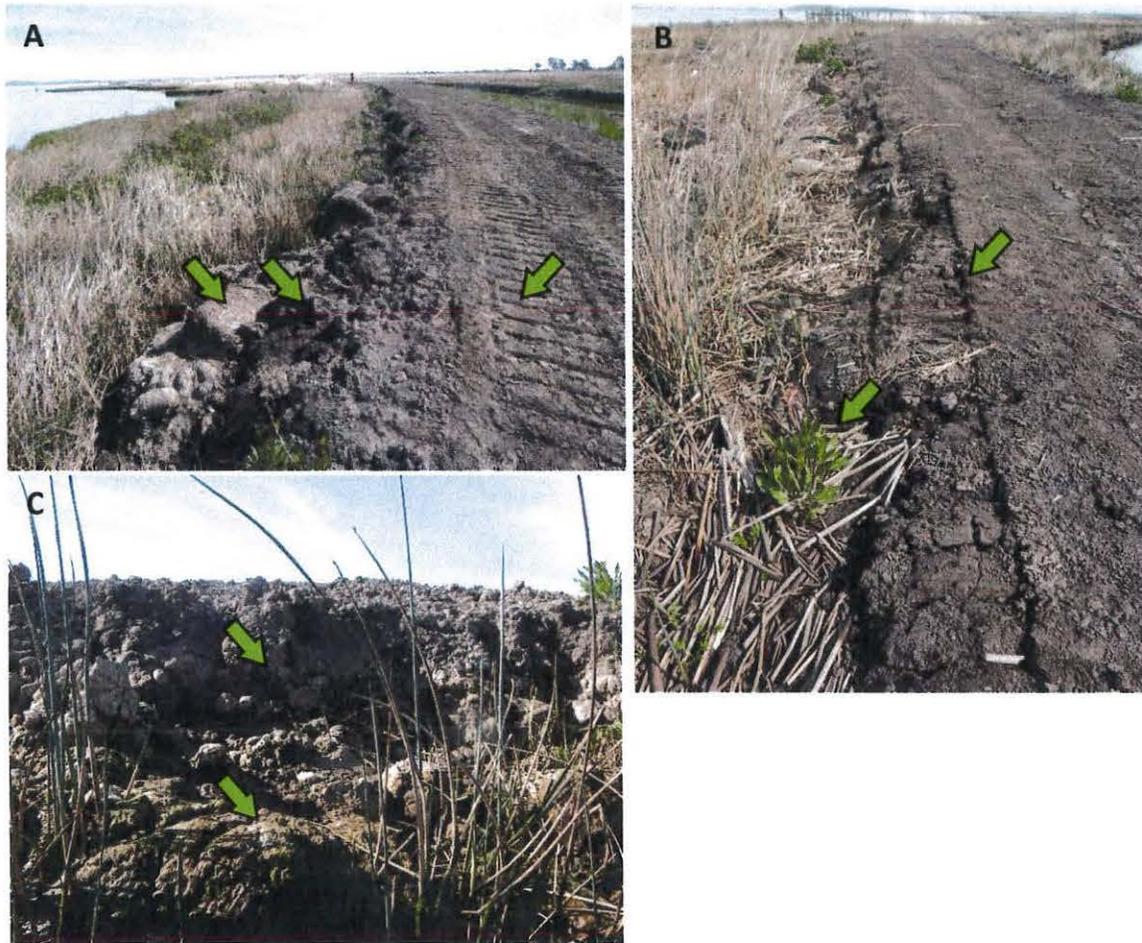
Photo 3. Spot Levee Repair Evidence during March 2, 2016 Site Inspection
Photos: Peter Baye

Some photos on the north shore levee (Photo 3) show recent tracked vehicle impressions and unvegetated mud without seedlings or previous year's weeds or marsh vegetation – consistent with recent levee capping or spot repair. Drift-lines are visible right up to equipment tracks. Also visible in Photo 3A and Photo 3C are what looks like a recent lift of dried mud placed over consolidated (erosion-smoothed) older levee mud.

The Opposition Brief assertion appears to be based on the occurrence of tides at HTL heights, namely 8.2 ft NAVD88, flowing over the lowest surveyed levee centerline elevation, 6.7ft NAVD88, following levee construction. However, no such extreme high tides have occurred since the levee was constructed, the highest recorded tide at Port Chicago being 7.3 ft NAVD88. Shallow low-energy overtopping for a brief period has modest erosion potential, and we found evidence during the March 2, 2016 Site inspection of recent 2016 levee spot repair consistent with moderate overtopping erosion (see Photo 3).

Thus, even when tide levels rise above the lowest points of the levee, the length of levee that might be overtopped is short and the depths would be shallow. Overtopping itself may never occur, as it is the lowest elevation of the levee cross section at any given point that determines whether overtopping occurs. The levee crest is by no means a perfectly flat surface. Undulations of half a foot were observed during the March 2, 2016 site inspection, so it is entirely possible that no overtopping conditions have arisen since the unauthorized levee was completed, and field evidence from the March 2, 2016 Site inspection indicates that spot levee repairs were made.

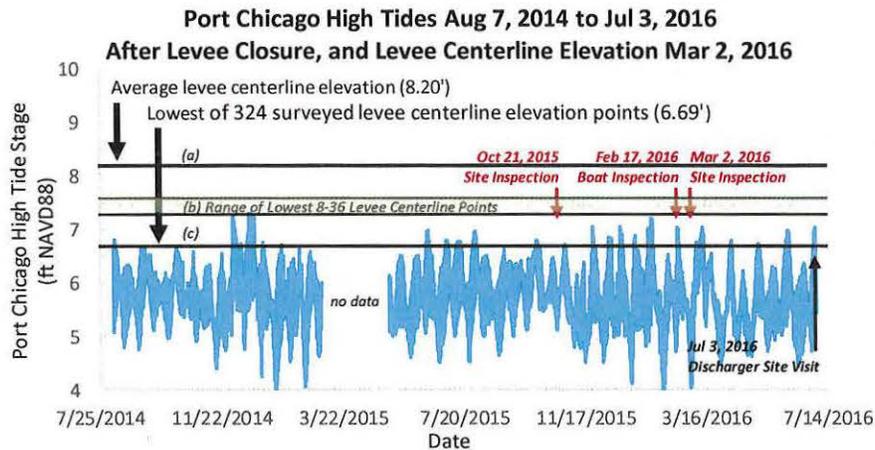
Figure 11. Average Levee Centerline Surveyed Elevations and Port Chicago High Tides After Levee Construction

Figure 11 shows the Port Chicago high tides from August 7, 2014 to July 3, 2016 and surveyed levee centerline elevations, representing (a) average levee centerline elevation, (b) range of the lower levee centerline elevation points, and (c) the lowest surveyed levee centerline elevation (Appendix I of the May 2016 Technical Assessment). The range in (b) allows consideration of tide height variation between Port Chicago and Point Buckler.

Note: Port Chicago station data has gap from 2/29/2016 to 5/6/2016

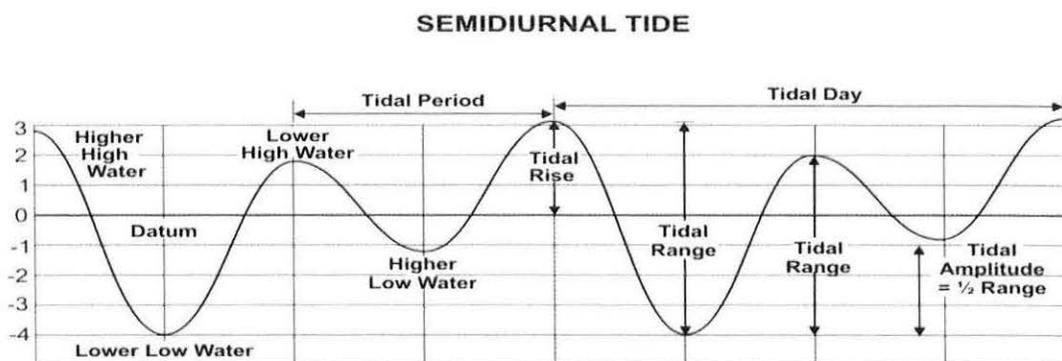
Figure 12. Mixed Semi-Diurnal Tides

The San Francisco Estuary experiences “mixed semi-diurnal tides”, meaning that each 24.5-hour tidal cycle consists of two high tides and two low tides, with different heights reached for all four of these tides. Each day there is a higher high tide, lower high tide, higher low tide, and lower low tide (Figure 12). Tides follow a 29-day cycle with the moon of greater and lesser ranges, with full and new moon driving the larger “spring” tides and quarter moons driving the smaller “neap” tides. Tides also follow an annual cycle of the earth rotating around the sun, with winter and summer solstices driving the large “king” tides (also known as “perigee tides”) and the equinoxes driving smaller tides. Lastly, tides follow an 18.6-year cycle combining a range of gravitational forces acting on Earth. These cycles are called “tidal epochs” and are the basis for tidal datum calculations by the National Oceanic and Atmospheric Administration (NOAA)⁴.

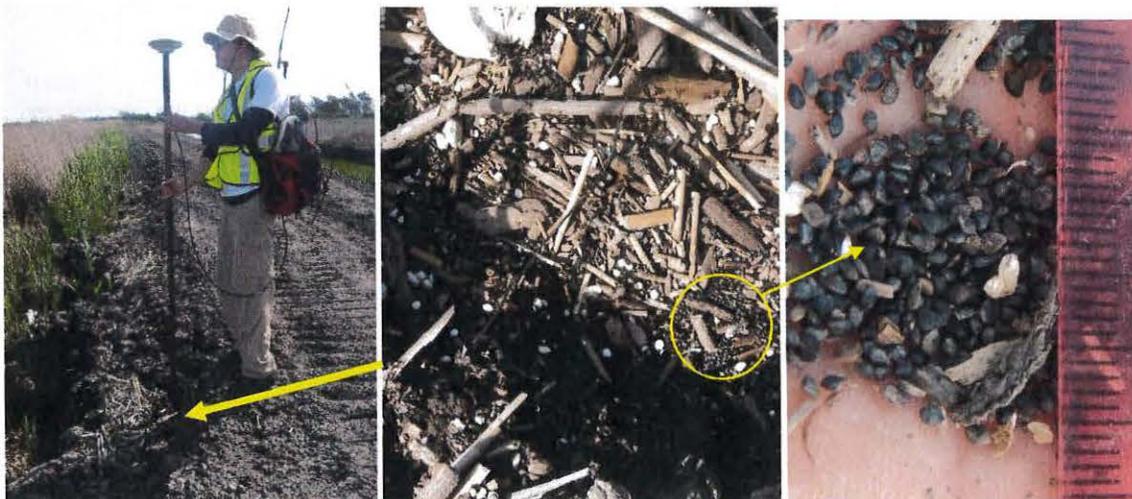
Photo 4. Debris Wrack Line Examples from March 2, 2016 Site Inspection

It is only in relatively wave-sheltered settings in the lee (shoreward) of dense, tall, marsh vegetation, or along shorelines with relatively low incident wave energy, that high tide lines can be confidently distinguished from wave-deposited drift-line elevation ranges above still-water heights of highest tides. This was in fact the basis of the Technical Report's High Tide Line sampling methodology in the Technical Report: drift-line elevations were sampled and compared in both wave-sheltered and wave-exposed settings: in the lee of tall wide wave-damping tulle and reed marsh, and in the lee of narrower marshes, and near old breaches lacking marsh. The elevation ranges of drift-lines, and the types of material in wave-sheltered, wave-damped levee shorelines guide the interpretation of drift-line elevations in wave-exposed settings where wave run-up (swash, uprush of breaking waves) is potentially significant. Data collection for high tide debris specifically included fine debris such as concentrations of bulrush seeds in wave-sheltered north-facing Point Buckler shorelines in the lee of dense, tall tules and reeds (Photo 4).

Field survey crews (March 2, 2016) specifically targeted elevation data on north shore Buckler Island drift-line deposits of fine debris composed of fine fibrous plant litter, bulrush seeds, and polystyrene, in sheltered positions behind dense, tall tulle and reed vegetation that attenuates wave energy.

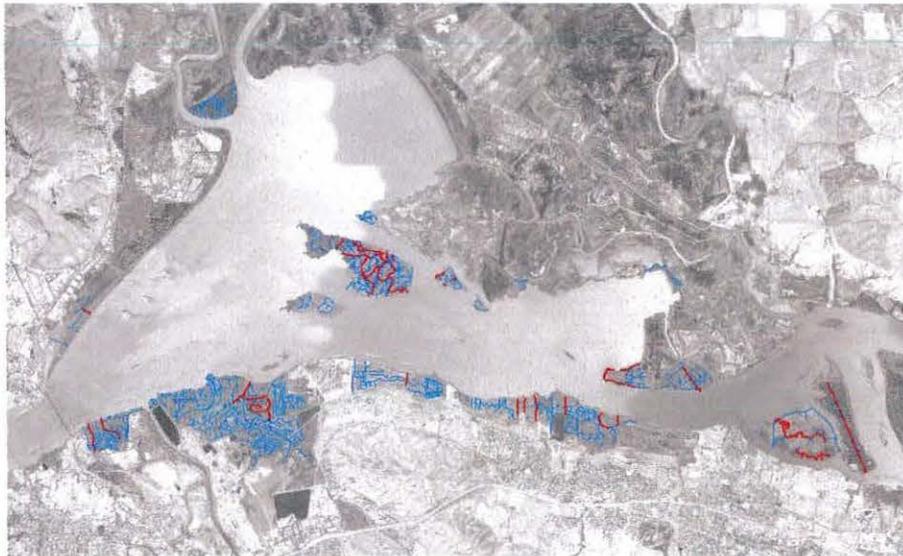
Figure 14. Extent of Small and Large Tidal Marsh Channels, Suisun Bay

Table 3. Length of Tidal Marsh Channels in Suisun Bay

Marsh Location	Length of Tidal Marsh Channels (ft)		
	Large Channels (> 40 ft avg width)	Small Channels (< 40 ft avg width)	Total
Browns and Winter Islands	26,128	27,207	53,335
Contra Costa Shore	29,130	400,377	429,507
Suisun/Grizzly/Honker Bay	45,593	195,822	241,415
Pt Buckler	-	9,558	9,558
Total	100,851	632,964	733,815
