Cargill, Incorporated Solar Sea Salt System Maintenance & Operations – Berm Integrity

Presentation to BCDC Engineering Criteria Review Board

November 16, 2022

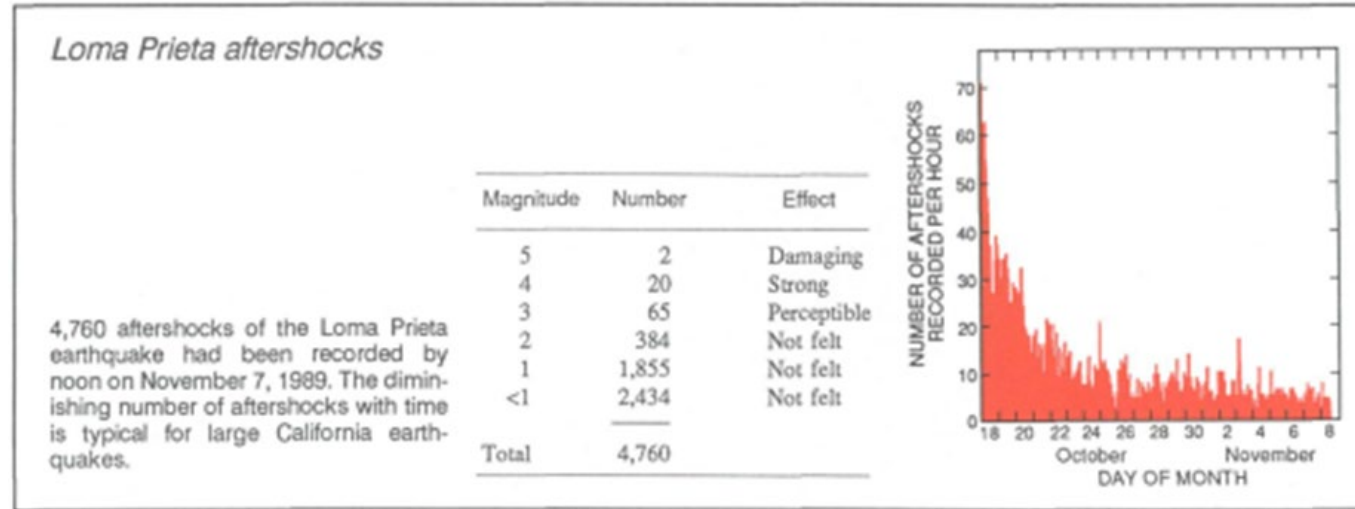
Seismic Performance - 1989 Loma Prieta Earthquake and Series of Aftershocks

- The initial seismic event was followed by thousands of aftershocks taking place over a 3-week period.
- Following the event, Cargill identified only minor cracking and settling in occasional locations.
 - Difficult to extrapolate berm future performance, but Loma Prieta provided an important indicator of their overall resiliency.
