2017 Marine Foundation Removal BCDC Commission Briefing

San Francisco-Oakland Bay Bridge East Span Seismic
Safety Project
April 19, 2018

Marine Foundation Removal

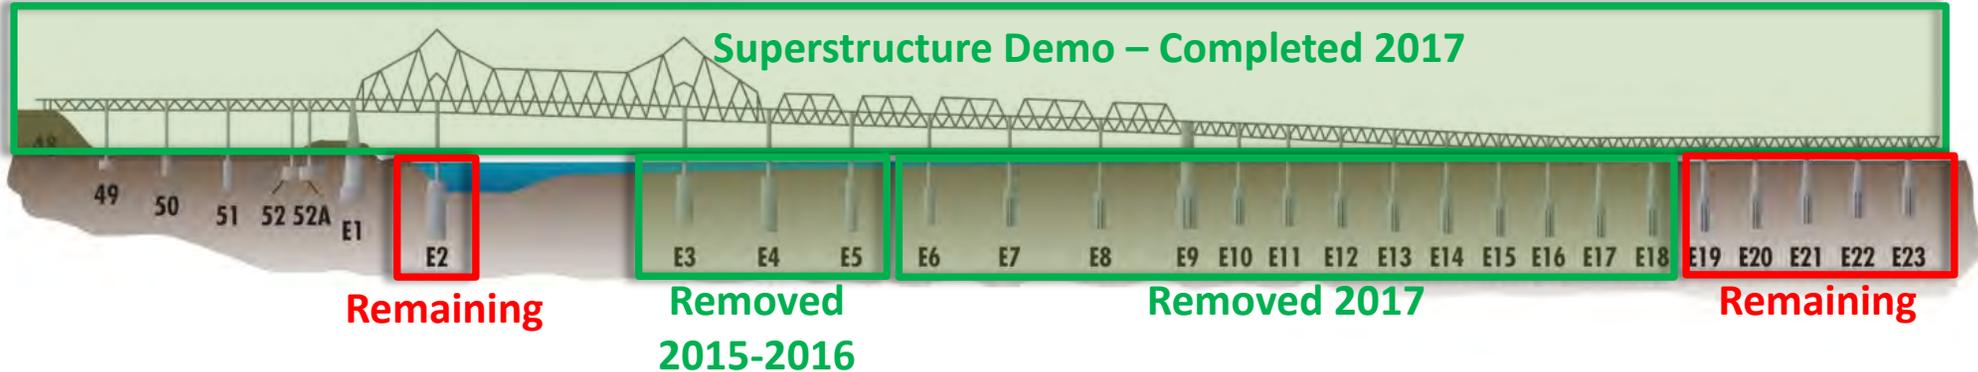
LOCATION

- Superstructure
- Piers E3 - E5
- Piers E6 - E18
- Piers E2, E19-E23

WORK SUMMARY

- Removal Completed 2017
- Removed in 2015 and 2016
- Removed in 2017
- Next Phase of Project

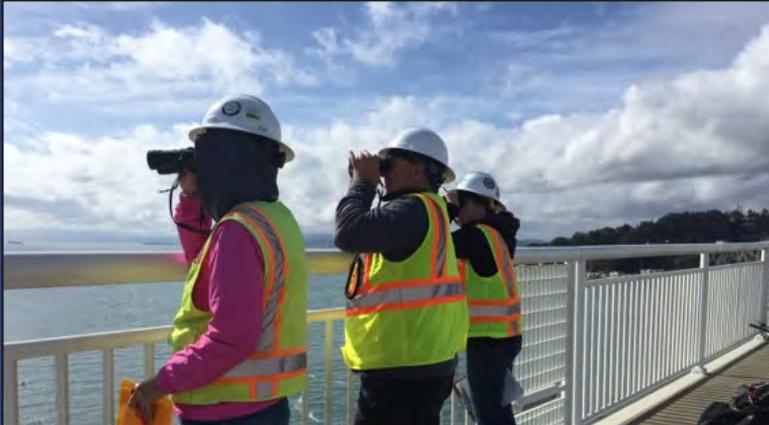
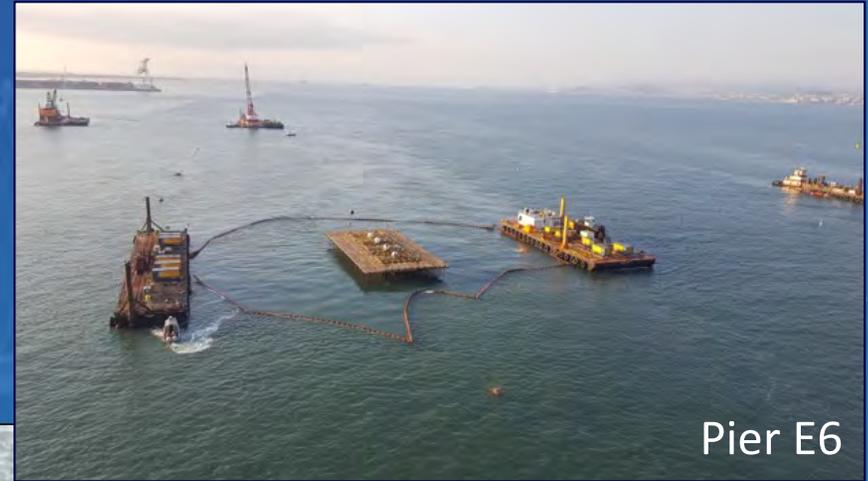
Pier E6

Summary of 2017 Pier Demolition Results

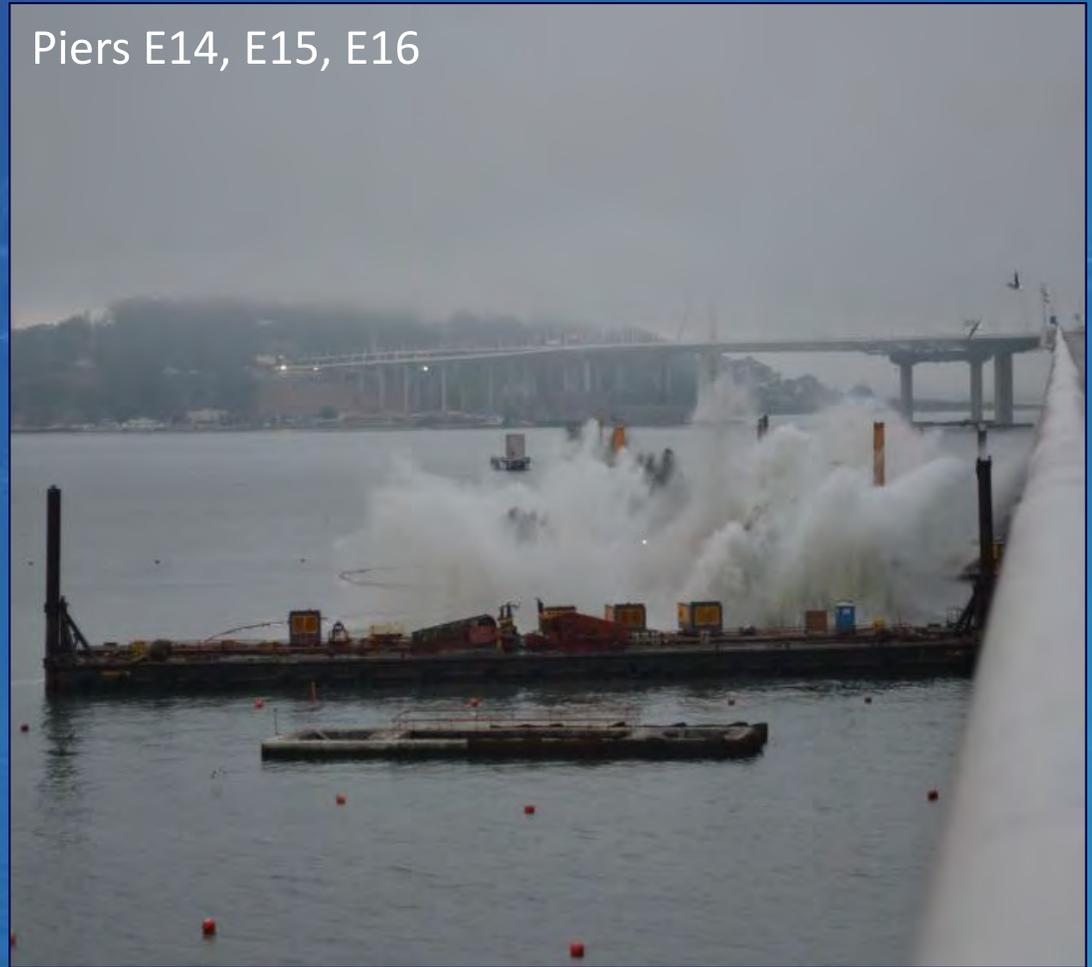
Piers E14, E15, E16

Pier Removal Process

- Above water portions mechanically removed
 - Wire-saw cutting, hoe-ram
- Drilling and loading of charges
- Implosion of underwater portions

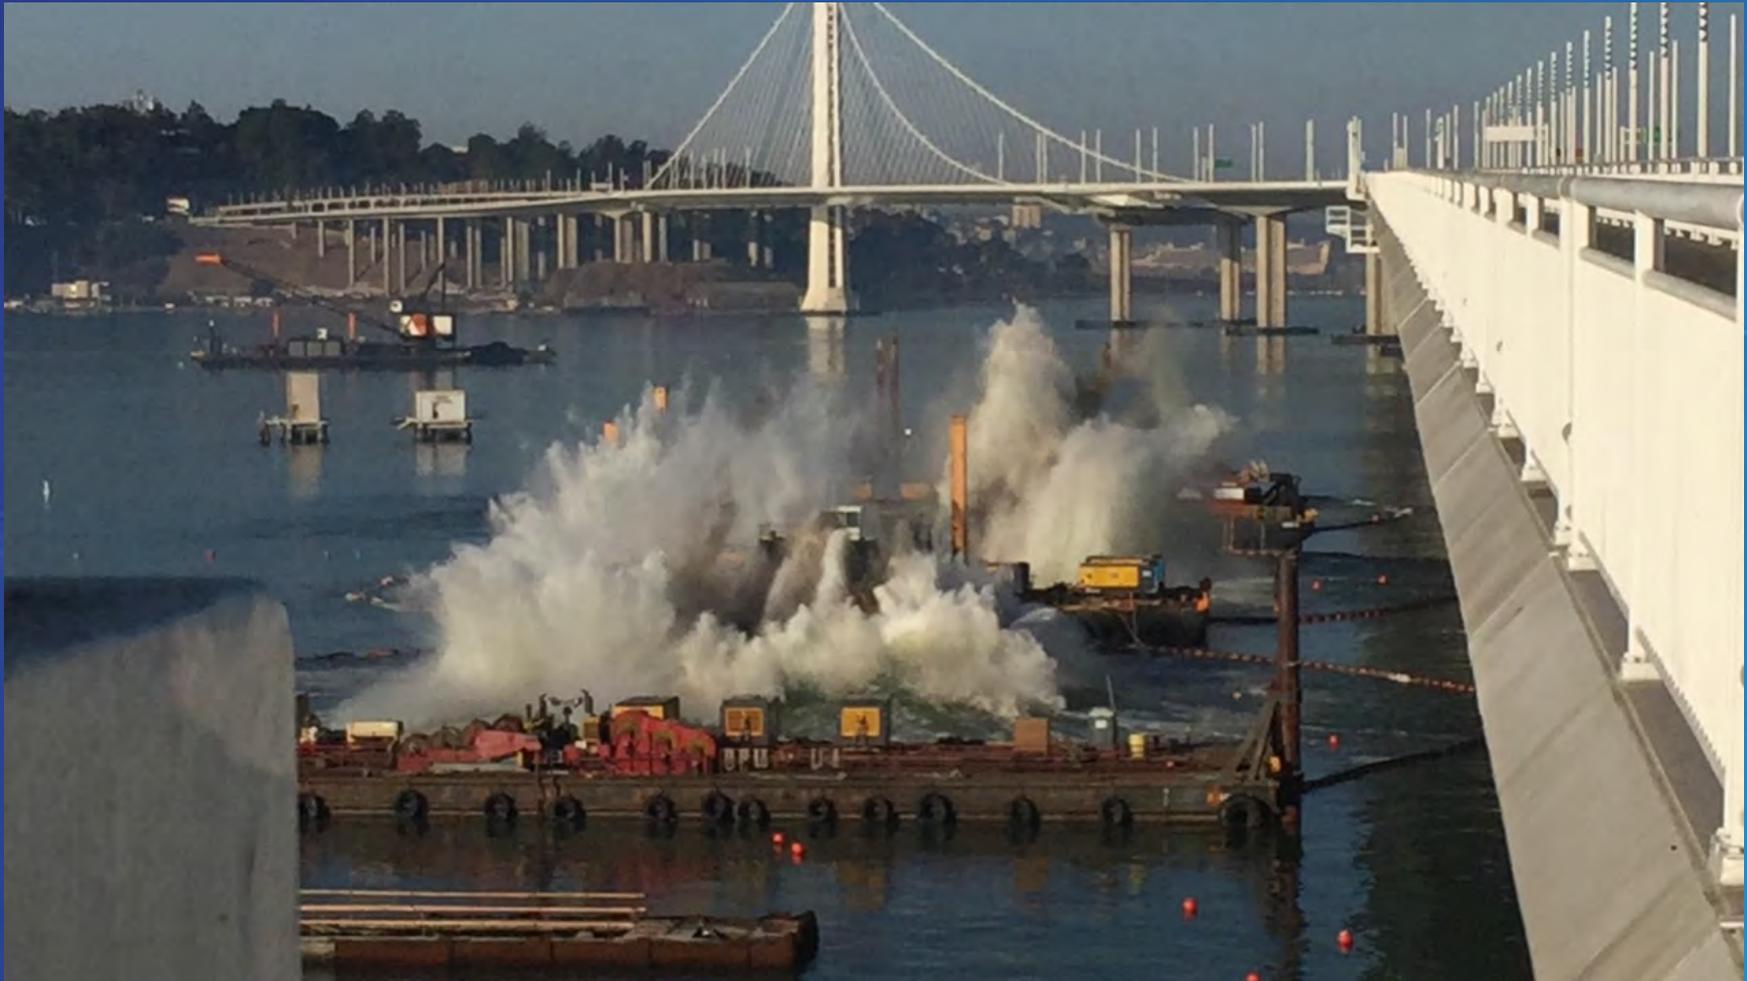
Post Blast Clean-Up

- Rubble removed to debris removal limit.
- Clean-up verified with bathymetry surveys
- Completed by November 30, 2017
- ~28,210 cubic yards authorized for in-situ (E4 to E18)
- ~24,180 cubic yards placed in-situ (E4 to E18)

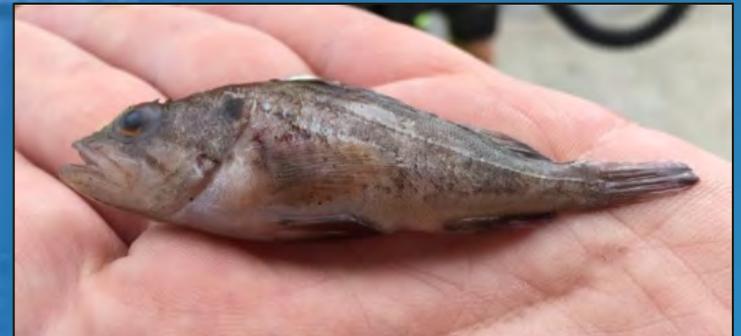
Fish Salvage

- Four boats: 2 outside debris boom; 2 inside debris boom
- Fish collected after each blast range 3 to 777 individuals (973 total cumulative)
 - Pier E6 outlier (629 anchovies collected)
 - Most prevalent species were brown rockfish and surfperch (excluding northern anchovy)
 - No FESA- or CESA-listed species observed or collected

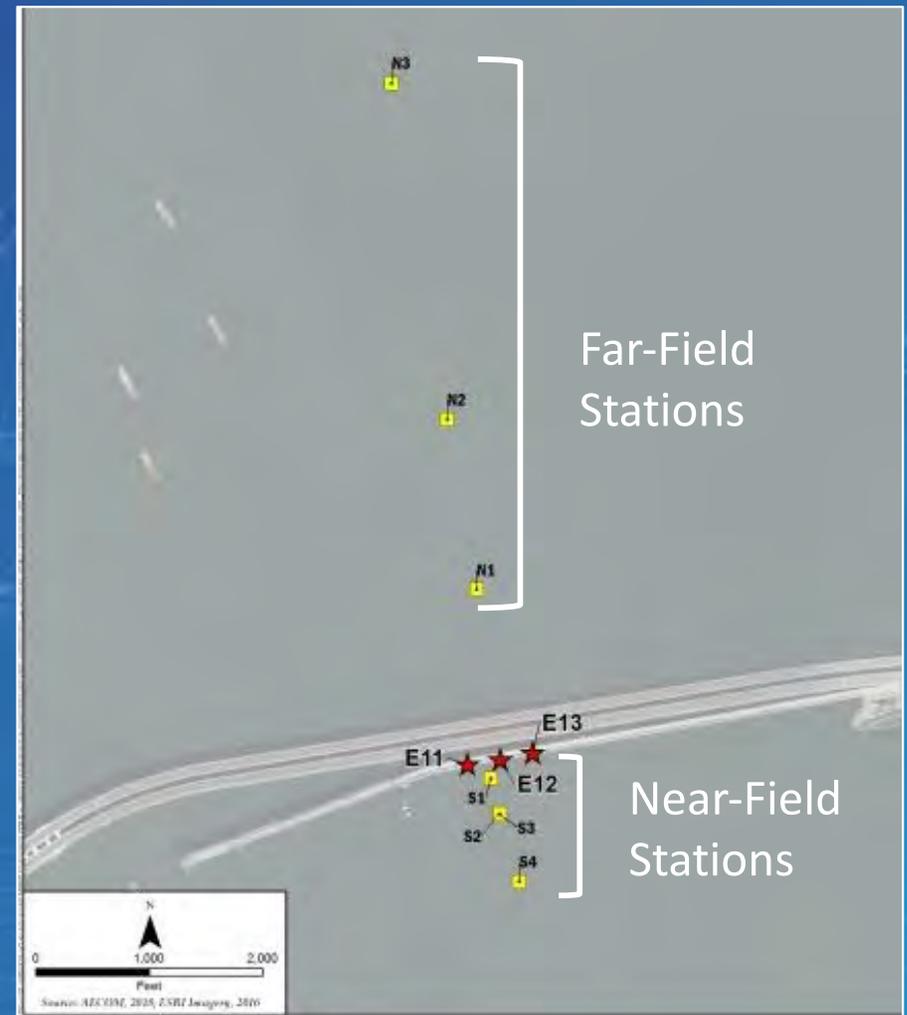
Example monitoring array (Piers E11-E13)

Hydroacoustic Monitoring

- Near-field monitoring all 6 controlled blast events within 1,100 feet
- Far-field monitoring on 4 of 6 controlled blast events from 1,500 to 6,000 feet

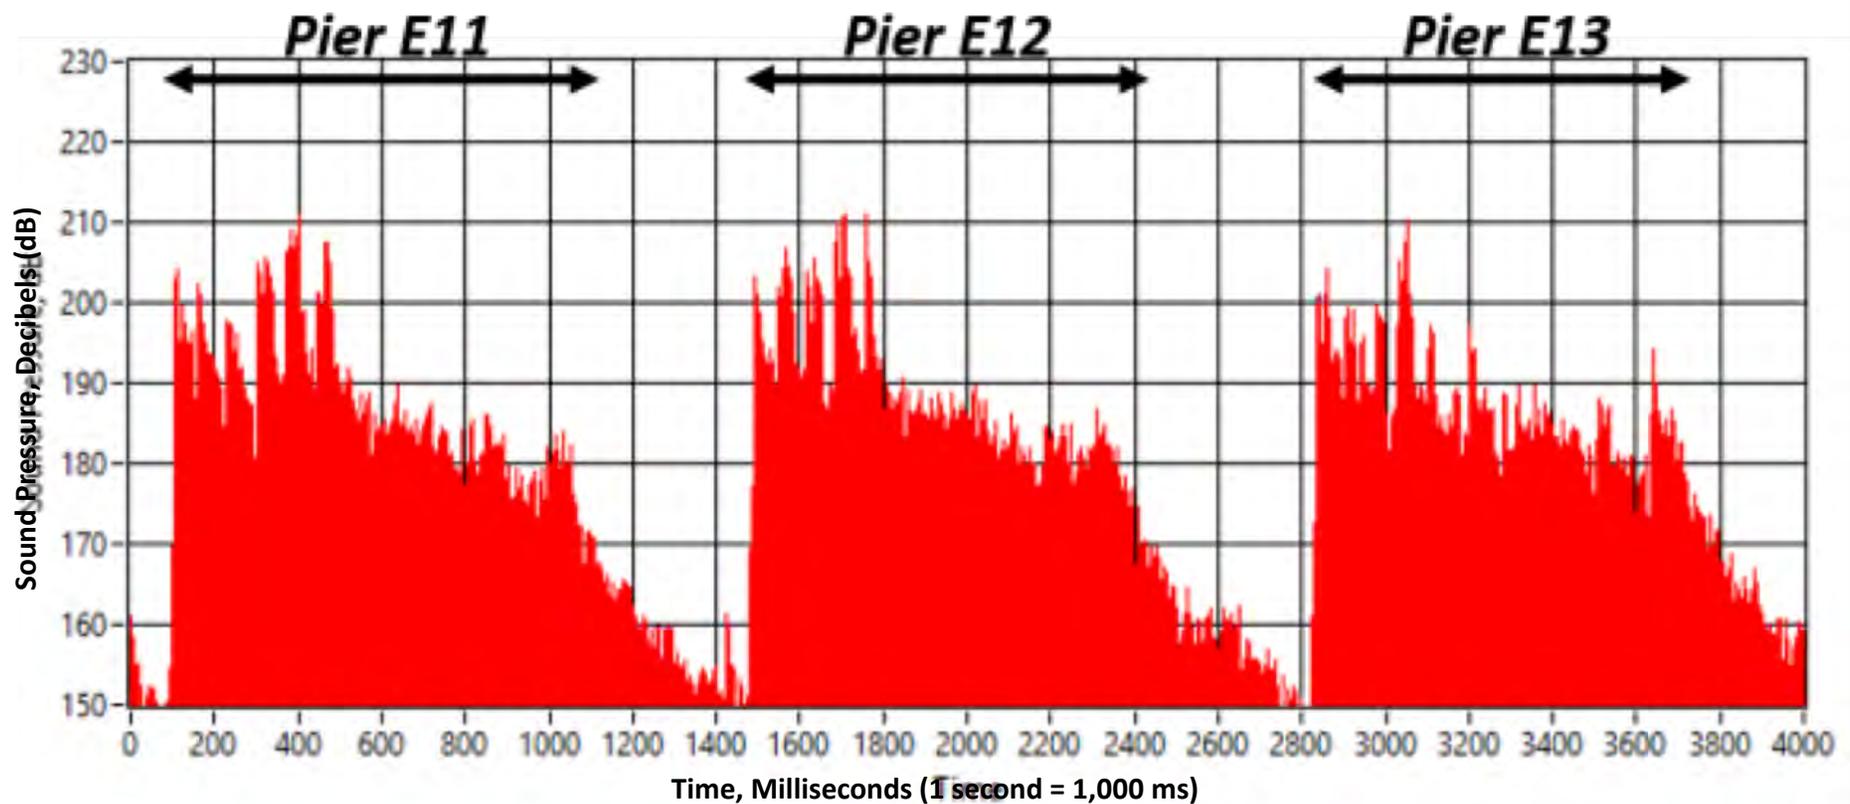
Example Sound Pressure Signatures at 500 feet (Piers E11-E13)
Half second between pier implosions

Hydroacoustic Monitoring Results to Fish Criteria

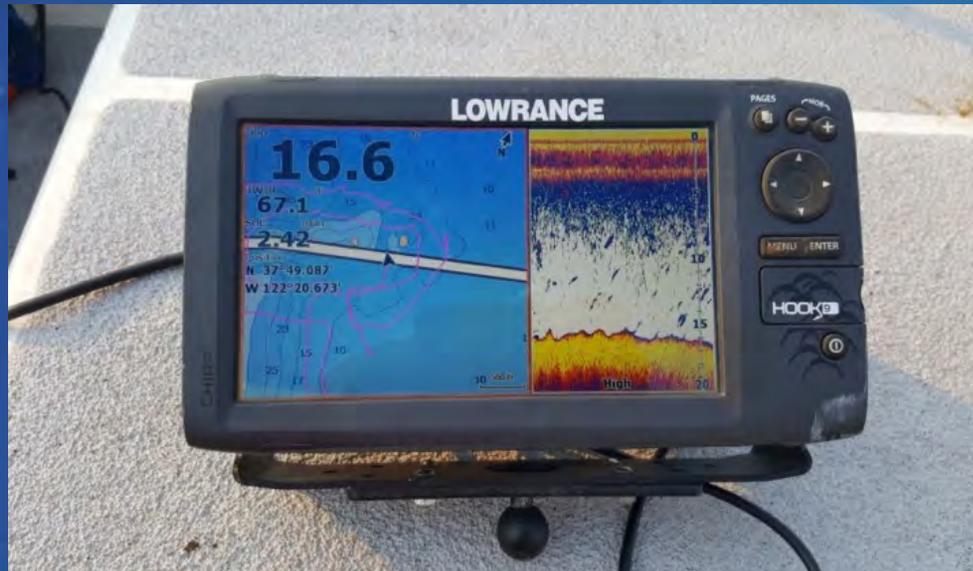
Fish Assemblage Survey

- Pre-Blast Sonar
 - Two sonar passes were made at approx. 500 and 750 feet around each pier approximately 4 hours prior to each event.
 - Very few areas of fish assemblages were noted in survey areas
 - Correlation difficult to see when compared to post-blast salvage

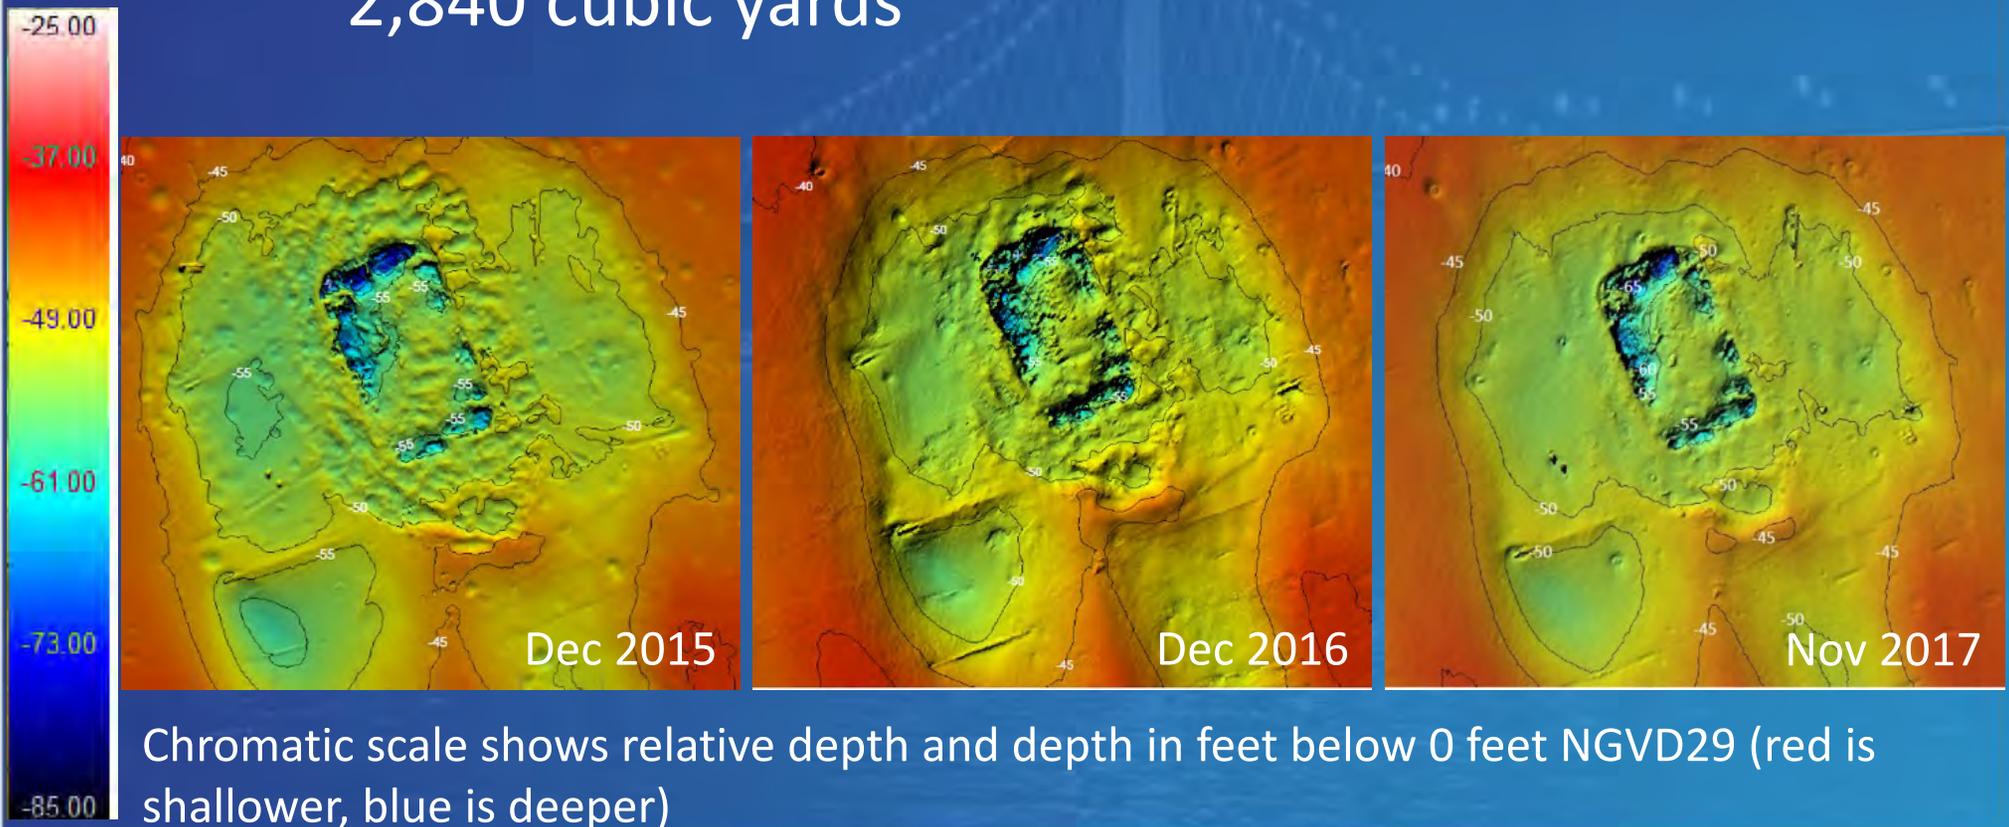
2017 Pier E3 Infill Monitoring

- Net gain in sediment from 2015 to 2017 of 2,840 cubic yards

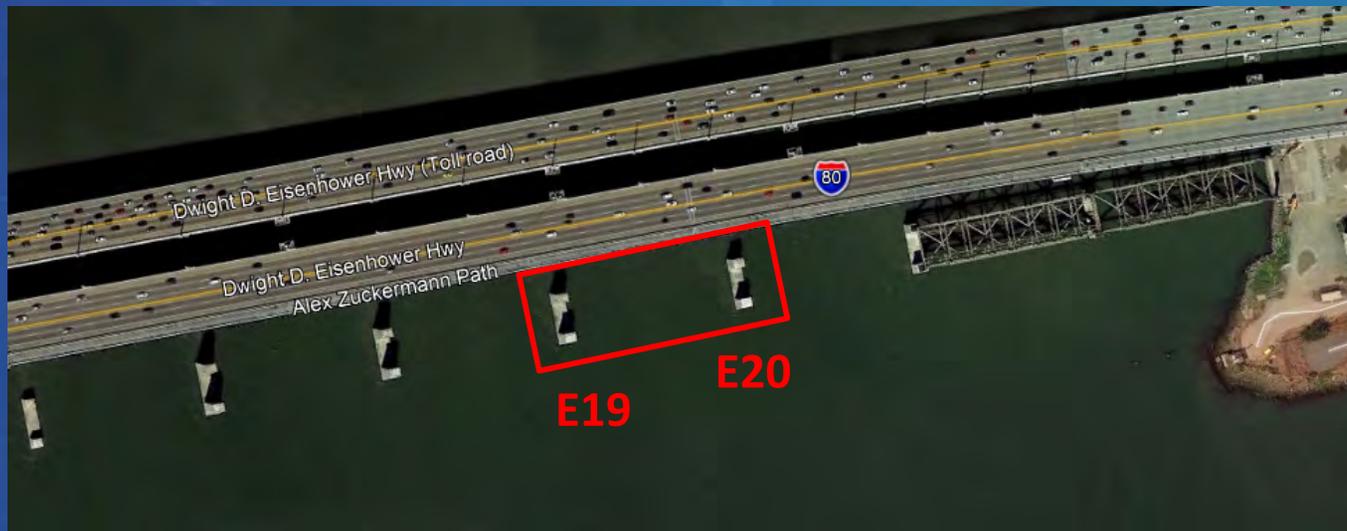
Pier Demolition – E19/E20

- Demolition using controlled implosions
 - Above water mechanical demolition
 - Below water implosion/ rubble removal
 - Monitoring resources following protocol implemented during 2017 blast events
