*San Francisco–Oakland Bay Bridge
East Span Seismic Safety Project*

**Marine Foundation Removal Project
2017 Post-Blast Environmental Report**

March 2018

California Department of Transportation

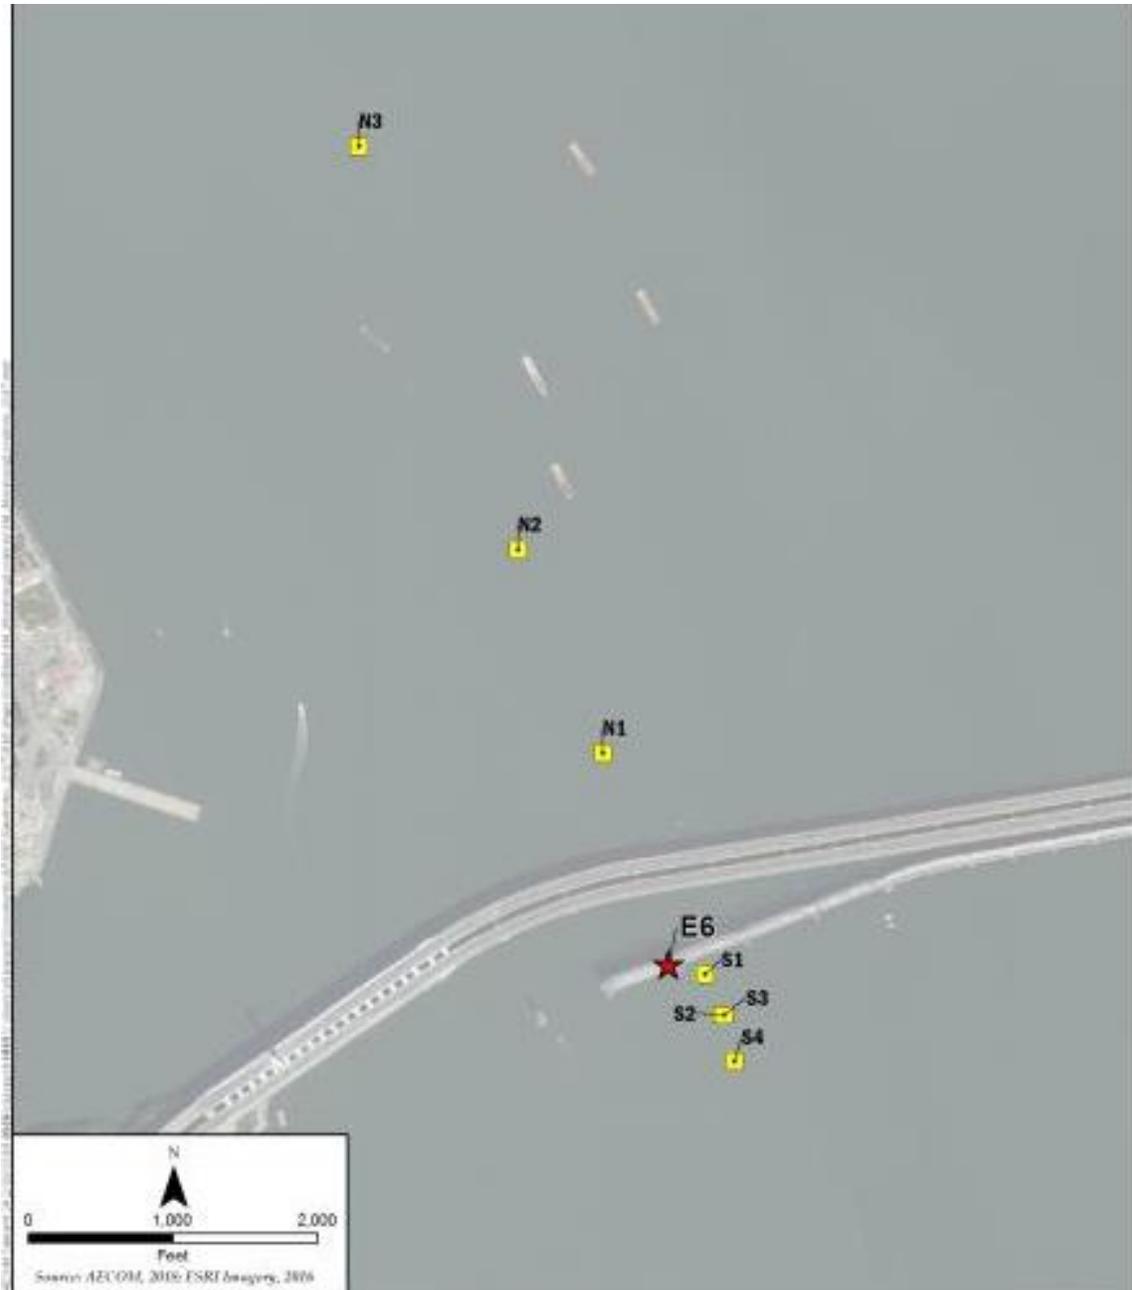
Figure 3-2. Deployed Near and Far-Field Locations where Data was Collected during the Implosion of Pier E6

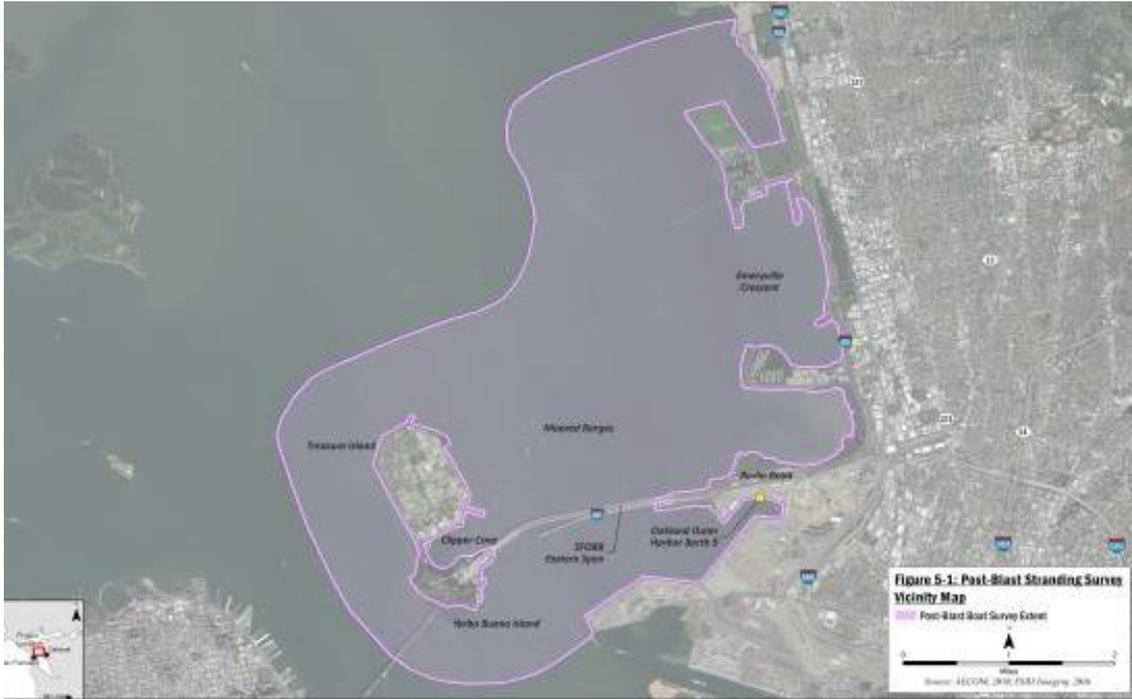
Figure 4-1. Stranding Survey Area

survey path varied slightly, depending on field and tide conditions. Land surveys were conducted along the shoreline at the OTD, at the Emeryville Crescent, and along the shoreline north of the Oakland toll plaza and SFOBB approaches. The shoreline includes two stretches of sandy beach, riprap, and portions of Radio Road, which runs parallel to the north side of Highway 80 west-bound.

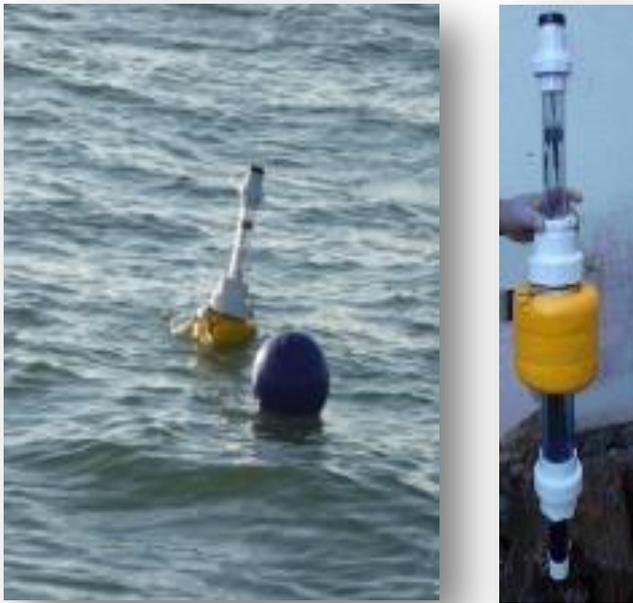
Figure 11-2. Current Tracking Drift Drogue

Drogues, which are floating monitoring devices that travel with tidal currents, were used to track the movement of the plume with the current and guide the profiling effort, capturing geo-spatial data in real-time (Figure 11-2). A drogue tender deployed window-shade drogues, equipped with GPS and radio transmitters in pairs after the implosion.
