**ALASKA BASIN BULKHEAD  
ALAMEDA, CALIFORNIA**

**SUPPLEMENTAL GEOTECHNICAL EXPLORATION**

December 6, 2016  
Revised November 15, 2018

9769.000.001

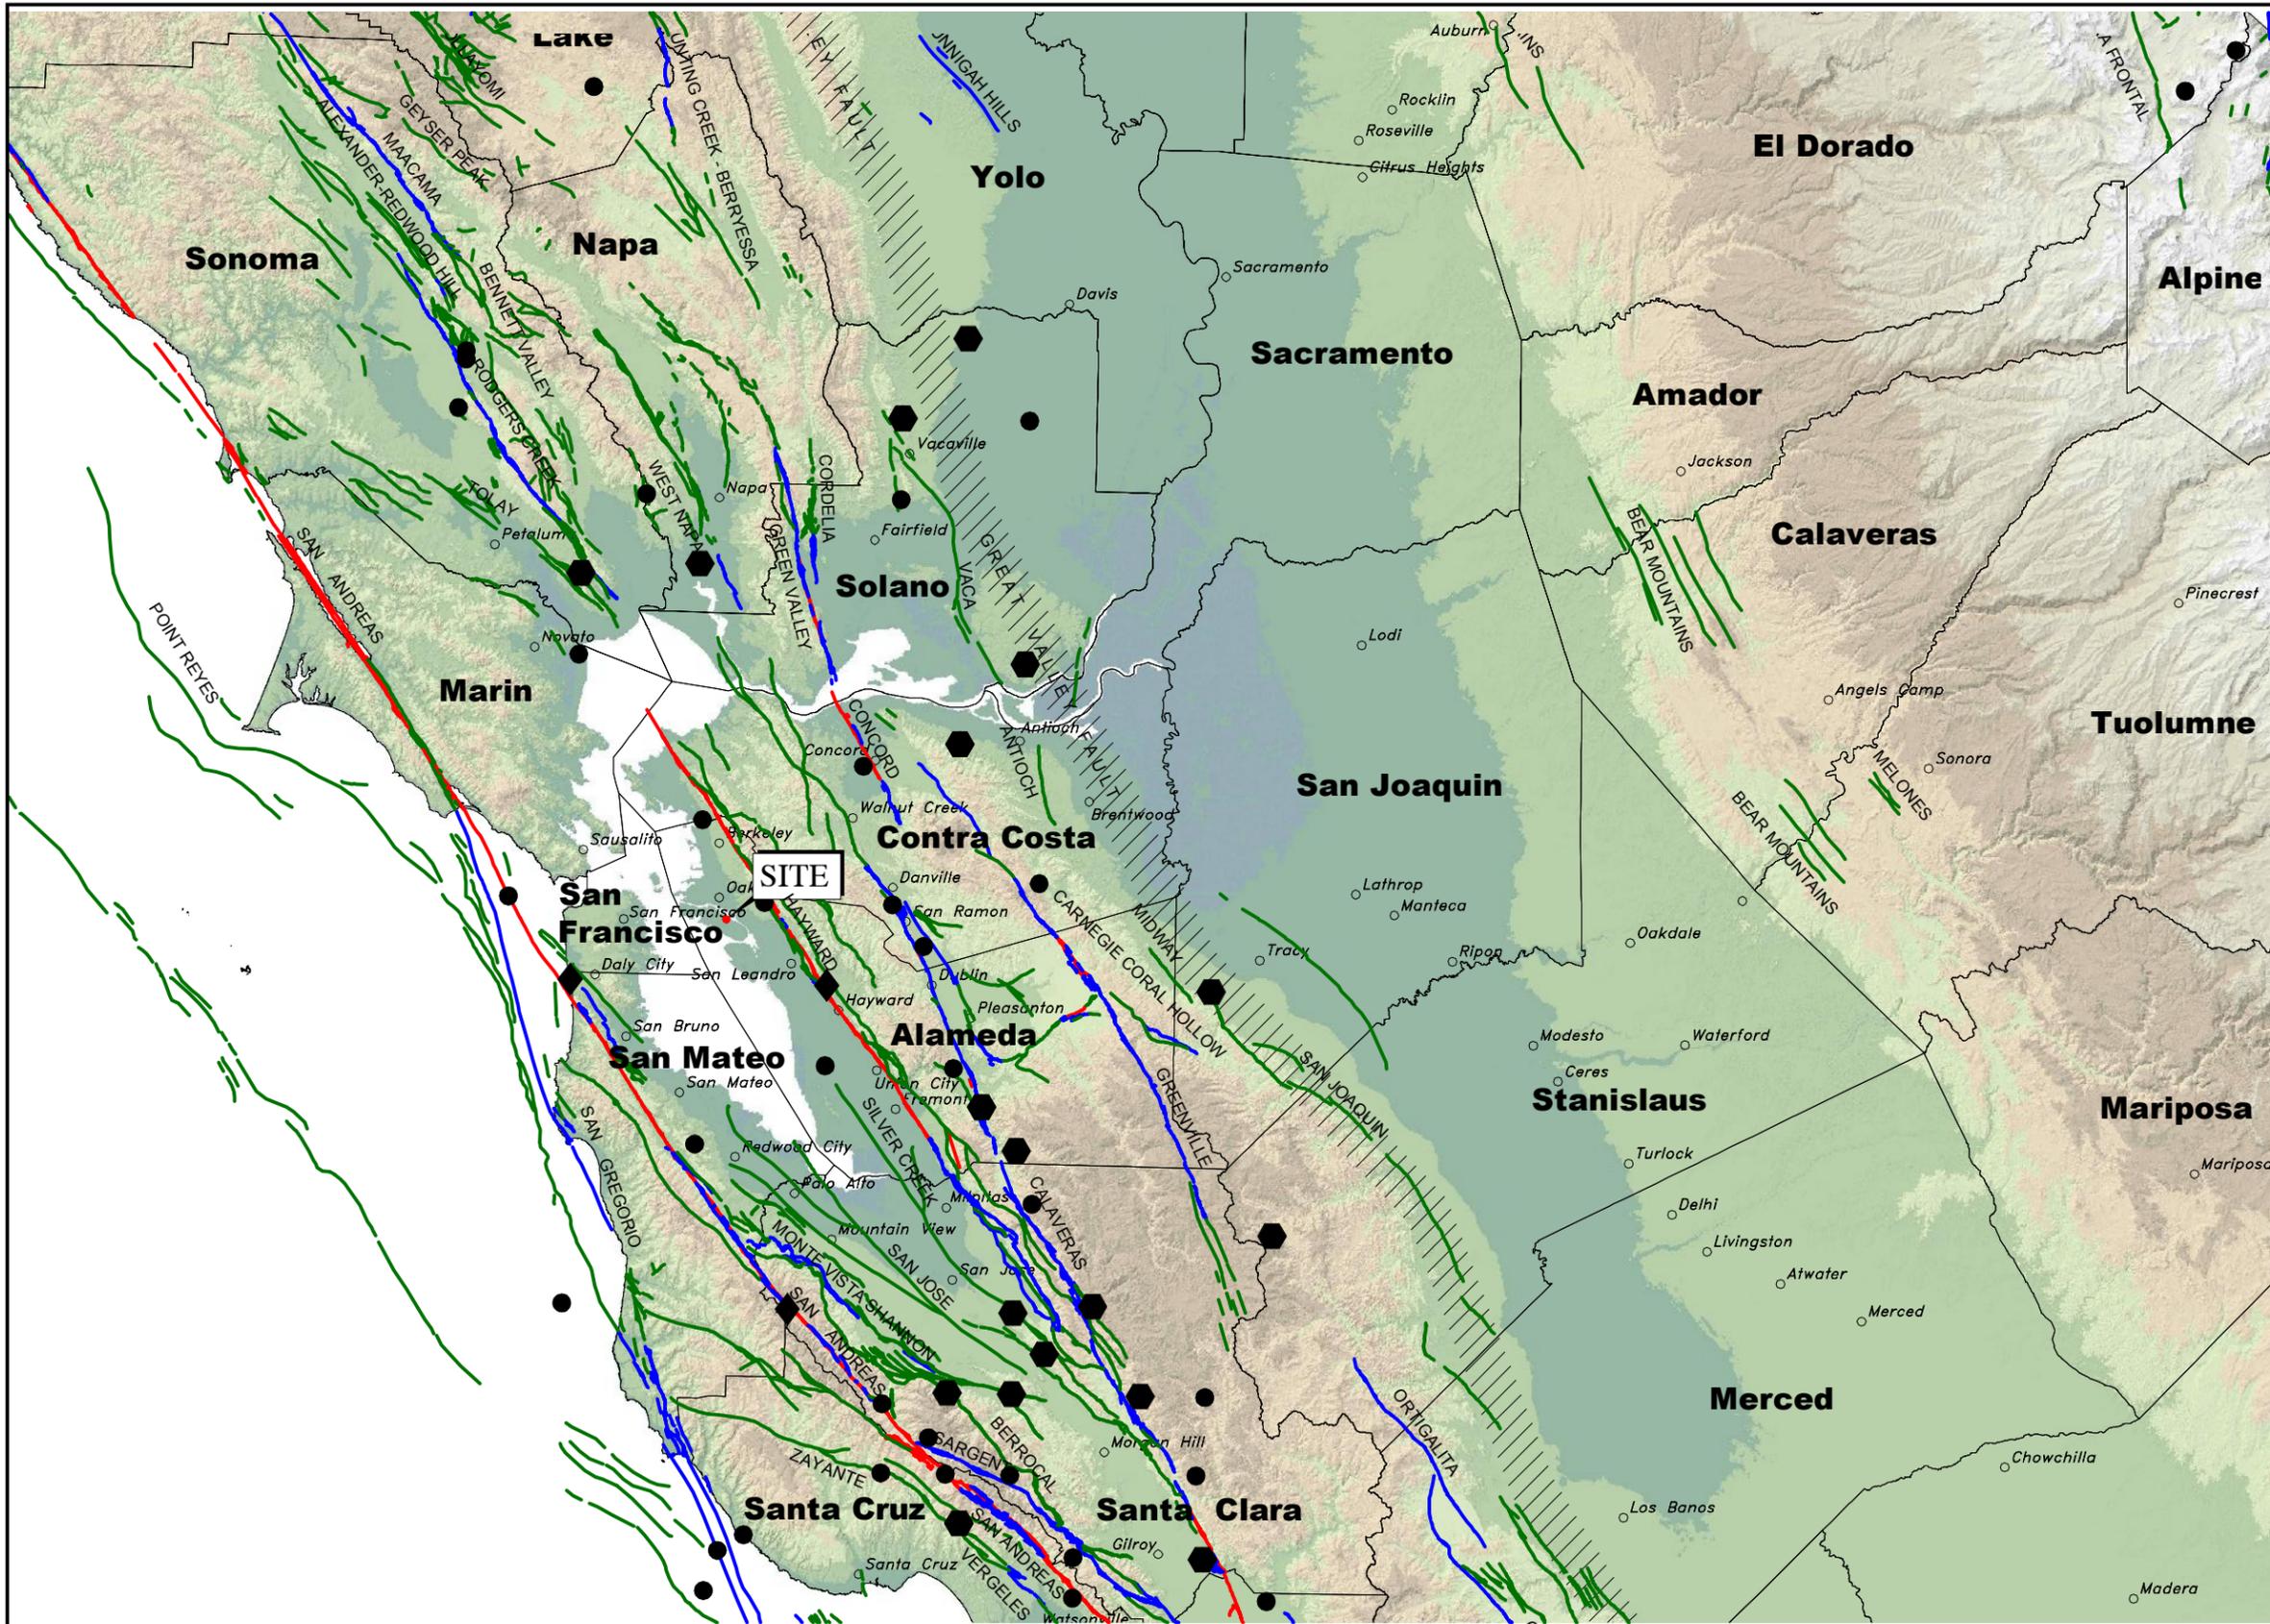
REGIONAL FAULTING AND SEISMICITY ALASKA BASIN BULKHEAD ALAMEDA, CALIFORNIA		PROJECT NO.: 9769.000.001 SCALE: AS SHOWN DRAWN BY: LL    CHECKED BY: JAF	FIGURE NO. <b>3</b>
				ORIGINAL FIGURE PRINTED IN COLOR

EXPLANATION	
◆	MAGNITUDE 7+
⬠	MAGNITUDE 6-7
●	MAGNITUDE 5-6
— (Red)	HISTORIC FAULT
— (Blue)	HOLOCENE FAULT
— (Green)	QUATERNARY FAULT
///	HISTORIC BLIND THRUST FAULT ZONE

Numerous small earthquakes occur every year in the San Francisco Bay Region and larger earthquakes have been recorded and can be expected to occur in the future. Figure 3 shows the approximate locations of these faults and significant historic earthquakes recorded within the Greater Bay Area Region. The most common nearby active faults within 25 miles of the site and their estimated maximum earthquake magnitudes, based on the United States Geologic Survey (USGS) 2008 National Seismic Hazard Maps, are provided in the following table. An active fault is defined by the State Mining and Geology Board as one that has had surface displacement within Holocene time (about the last 11,000 years) (Hart and Bryant, 1997).

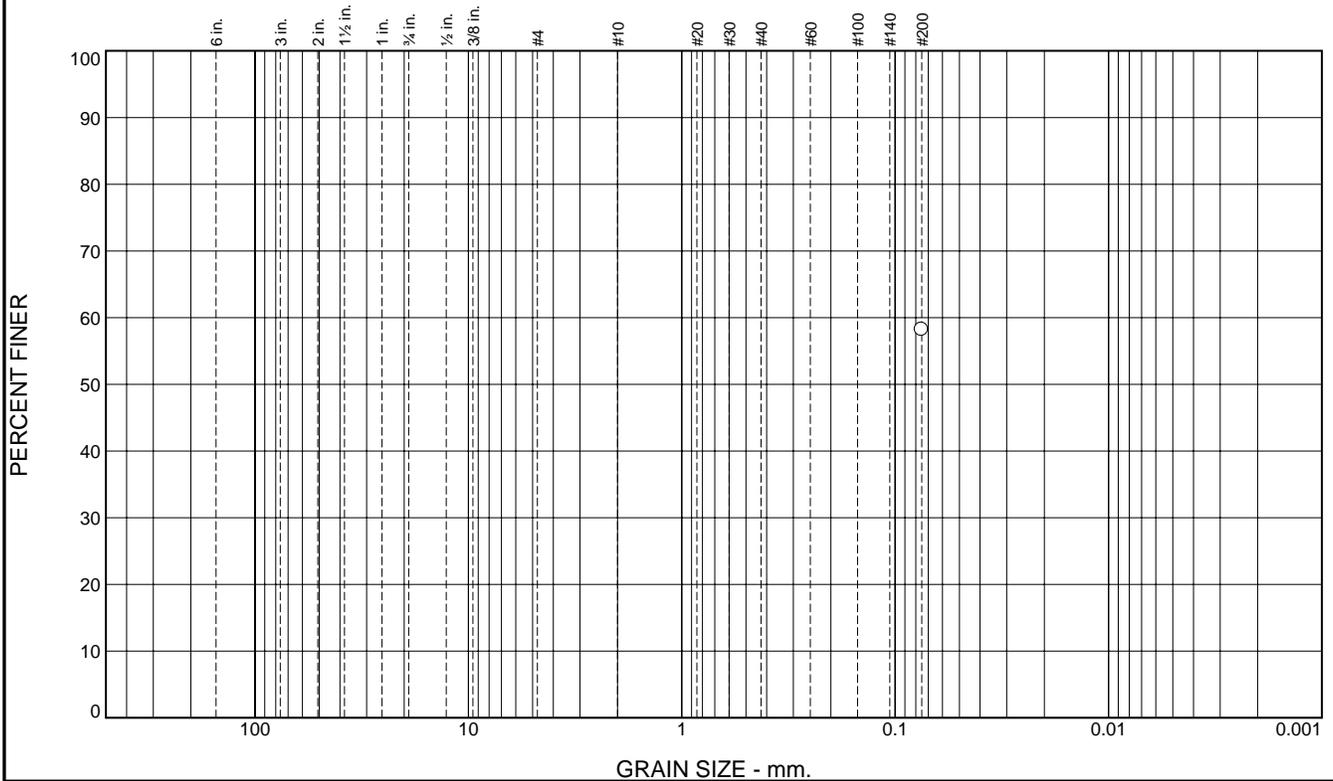
# Particle Size Distribution Report

% +75mm	% Gravel		% Sand			% Fines	
	Coarse	Fine	Coarse	Medium	Fine	Silt	Clay
						58.2

SIEVE SIZE	PERCENT FINER	SPEC.* PERCENT	PASS? (X=NO)
#200	58.2

To measure soil gradation, plasticity and moisture content, we tested push and drive samples recovered during CPT testing. A summary of laboratory testing and test methods as well as test results are presented in Appendix B.

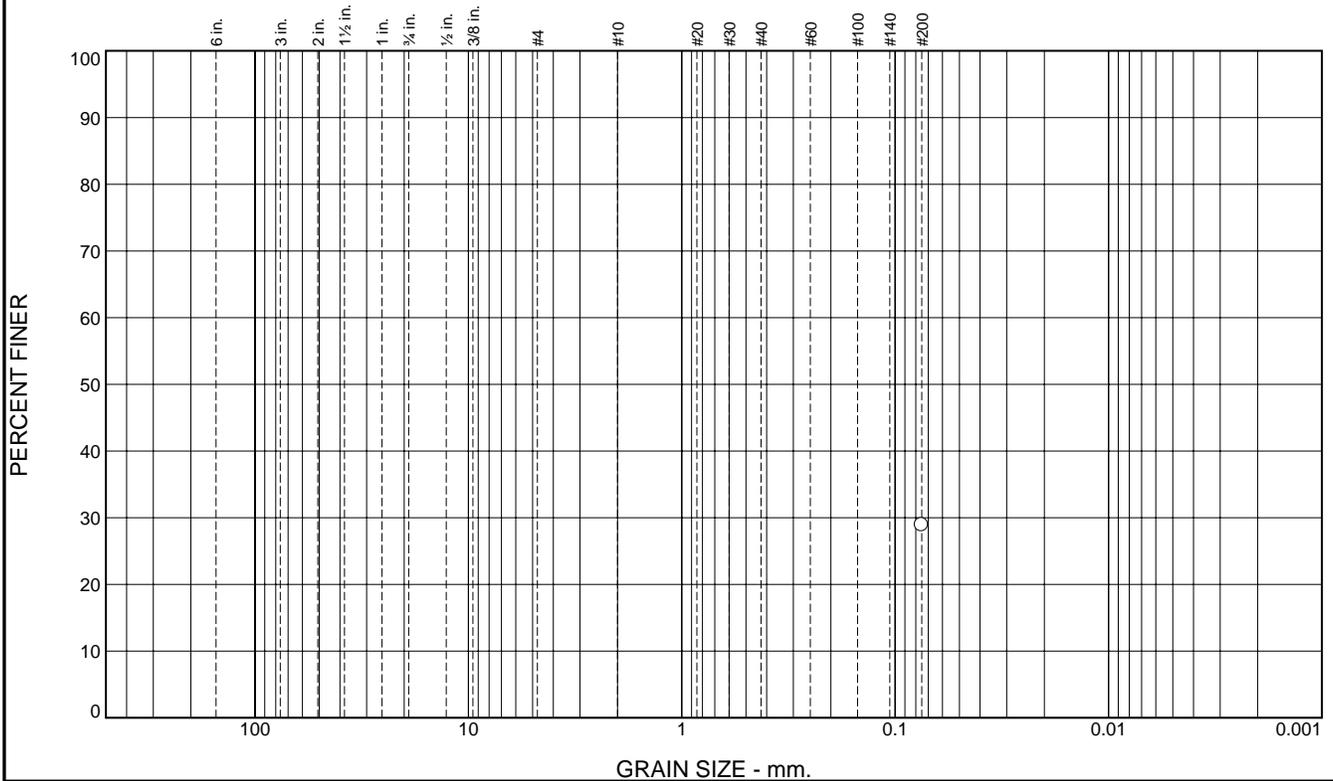
# Particle Size Distribution Report

% +75mm	% Gravel		% Sand			% Fines	
	Coarse	Fine	Coarse	Medium	Fine	Silt	Clay
						28.9

SIEVE SIZE	PERCENT FINER	SPEC.* PERCENT	PASS? (X=NO)
#200	28.9

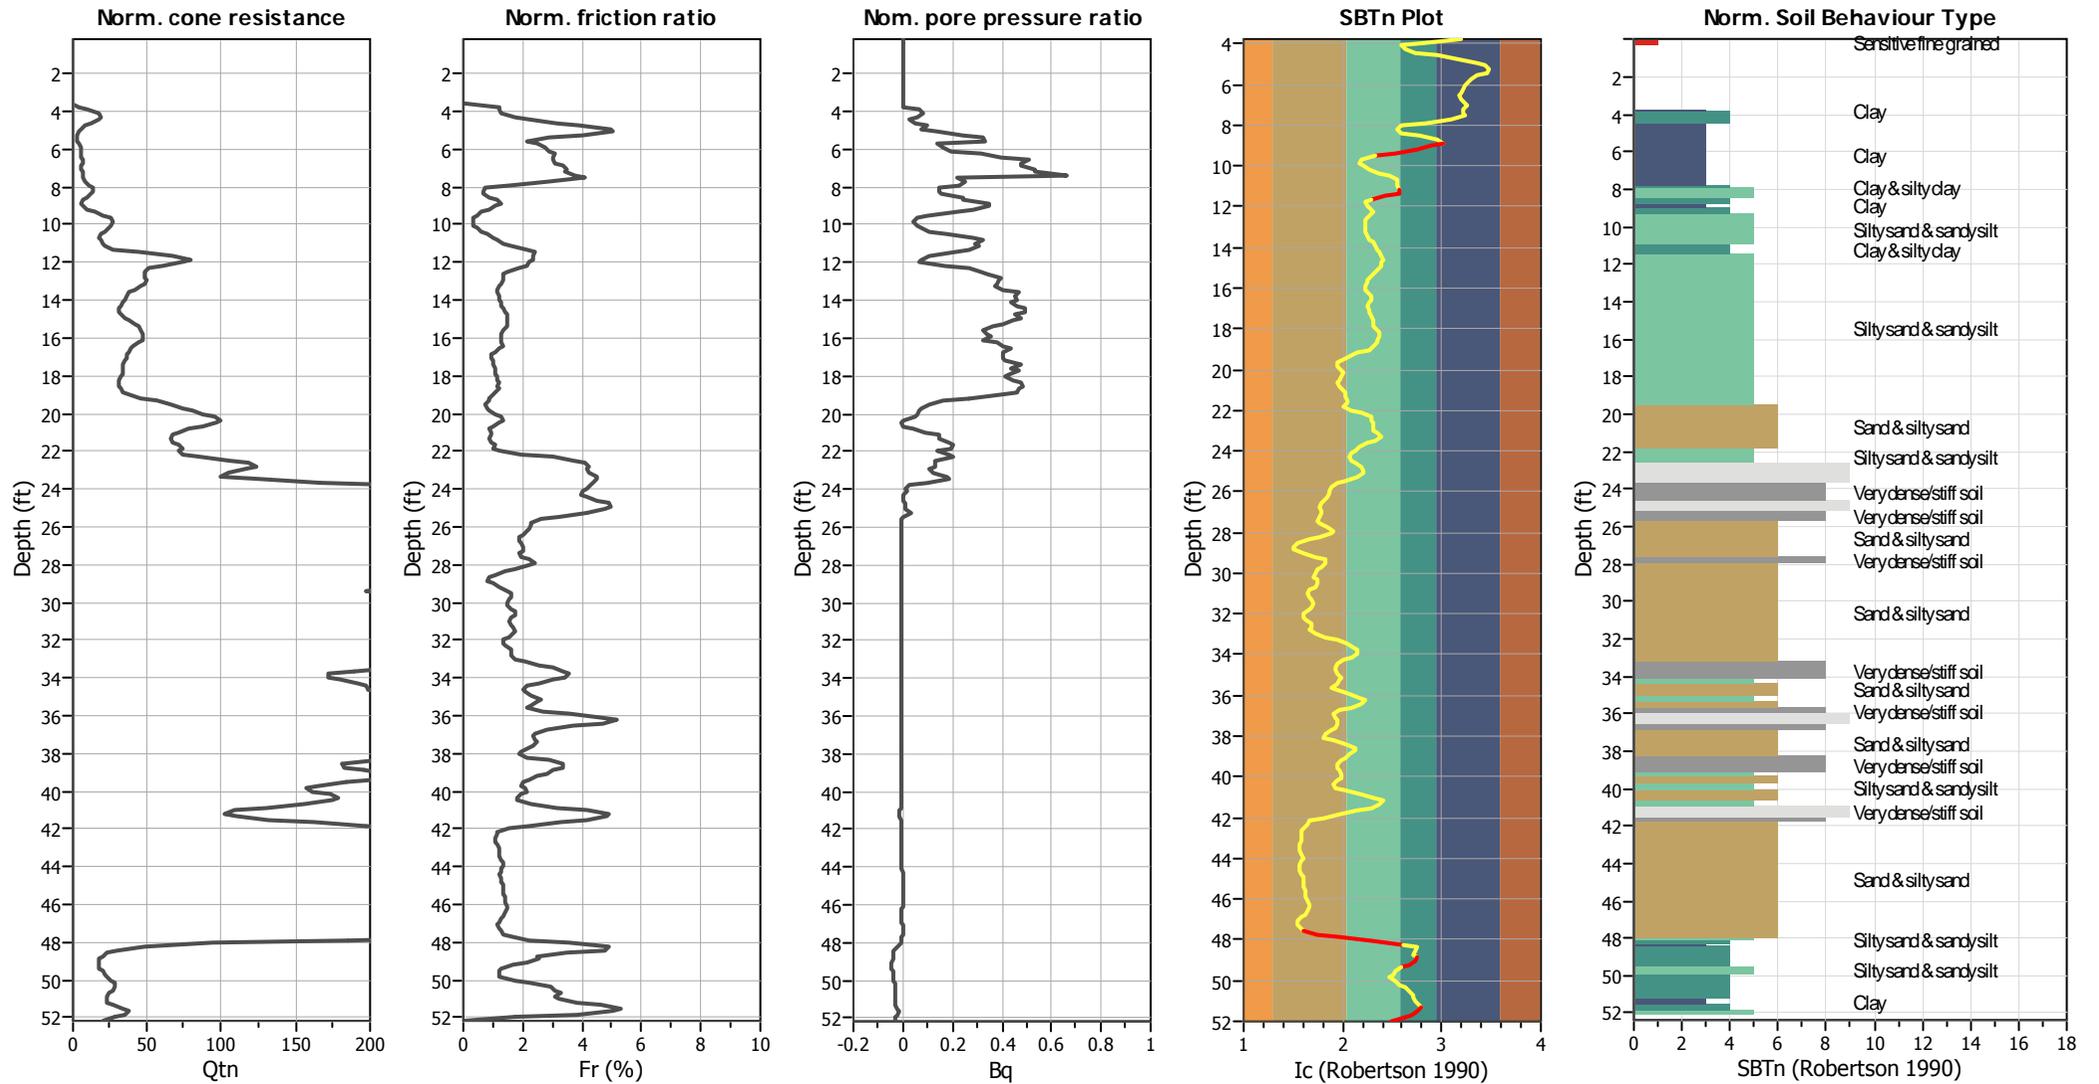
### CPT basic interpretation plots (normalized)

Analysis method:	I&B (2008)	Depth to GWT (erthq.):	5.00 ft	Fill weight:	N/A
Fines correction method:	I&B (2008)	Average results interval:	3	Transition detect. applied:	Yes
Points to test:	Based on Ic value	Ic cut-off value:	2.40	K <sub>q</sub> applied:	Yes
Earthquake magnitude M <sub>w</sub> :	7.33	Unit weight calculation:	Based on SBT	Clay like behavior applied:	Sand & Clay
Peak ground acceleration:	0.62	Use fill:	No	Limit depth applied:	No
Depth to water table (insitu):	5.00 ft	Fill height:	N/A	Limit depth:	N/A

We analyzed the liquefaction susceptibility of the bulkhead shoreline using methods developed by Idriss and Boulanger (2008). Based on this analysis, some of the soil in the upper 24 feet behind the bulkhead is potentially liquefiable. We recommend further analysis of the structural integrity of the actual bulkhead using pressures associated with liquefied soil and seismic loading. If the bulkhead cannot support these loads, remedial alternatives will be needed to stabilize the shoreline.

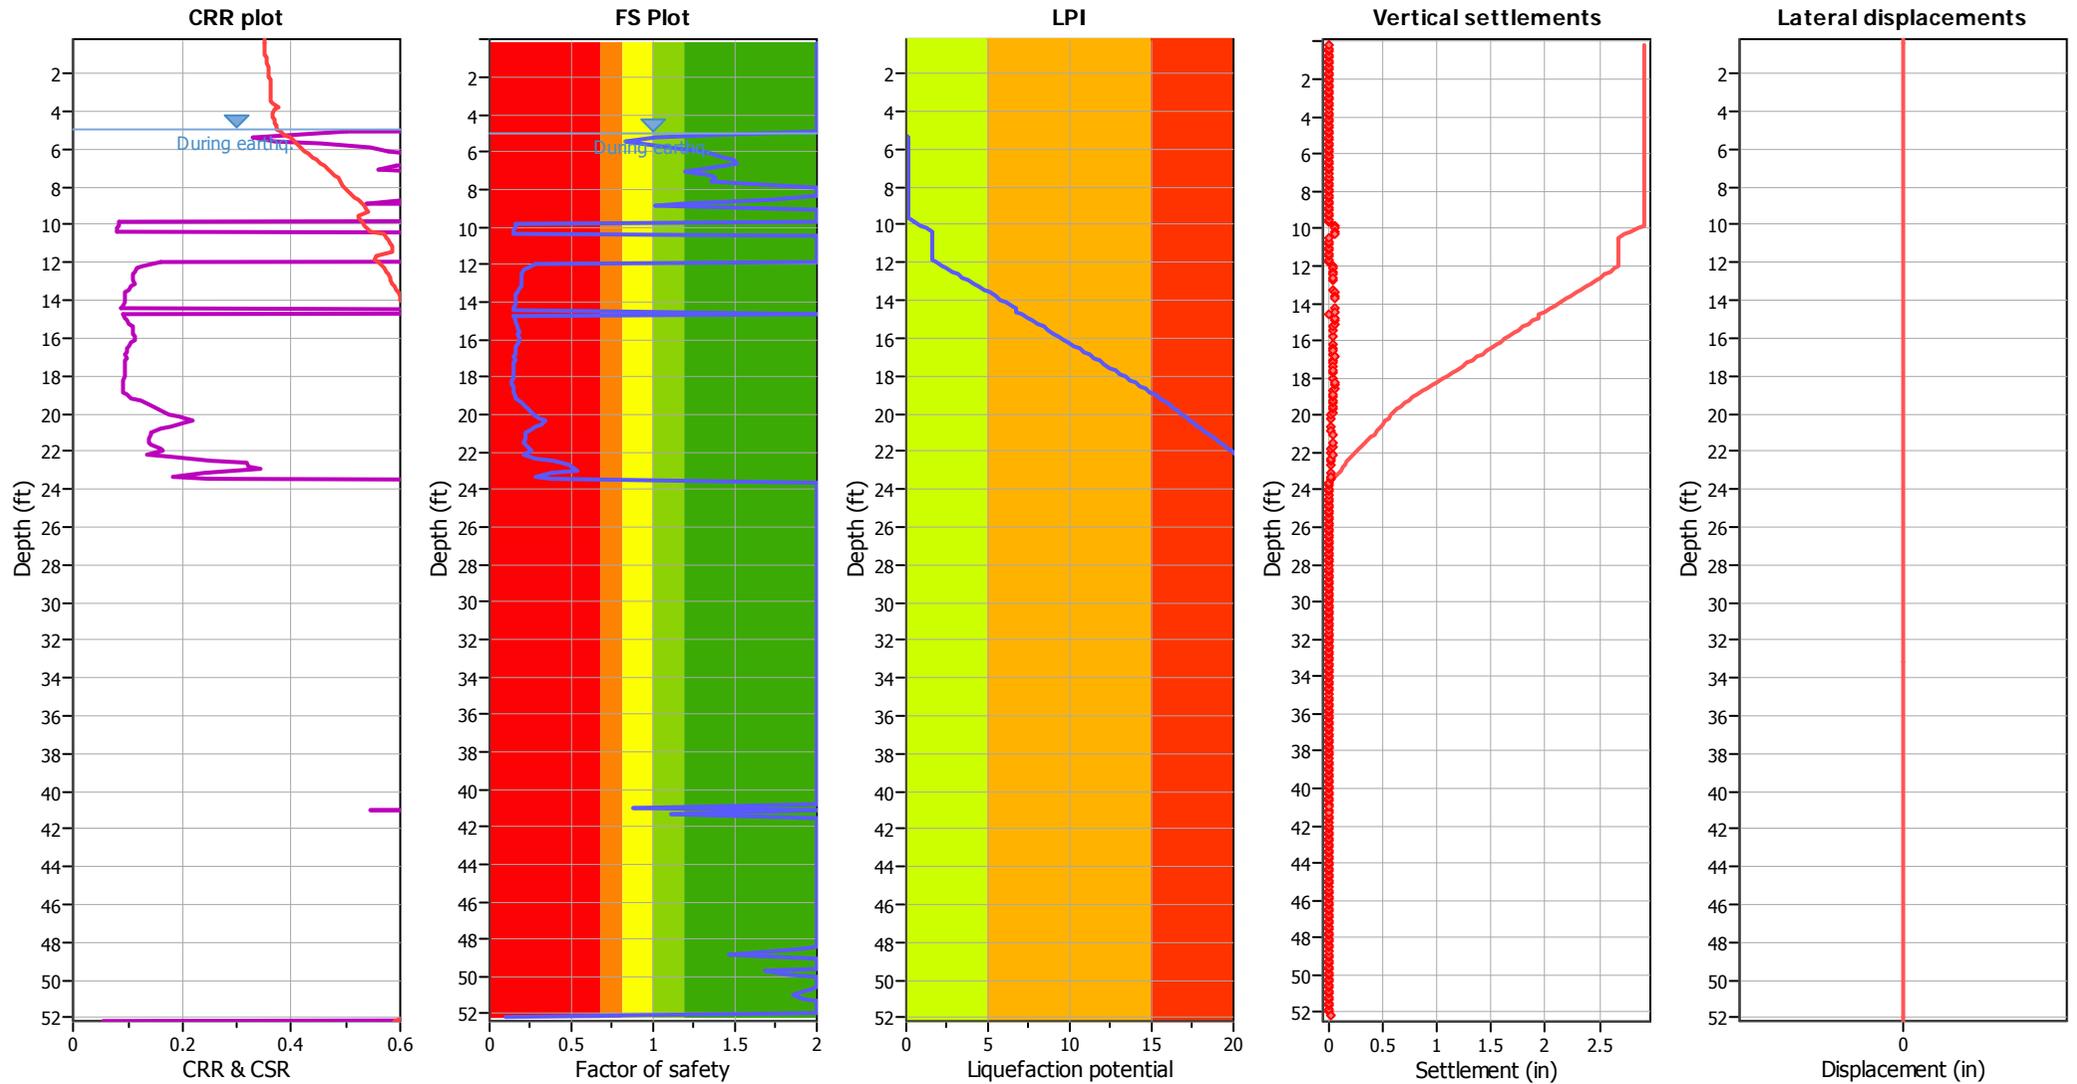
### Liquefaction analysis overall plots

Analysis method: I&B (2008)  
 Fines correction method: I&B (2008)  
 Points to test: Based on I<sub>c</sub> value  
 Earthquake magnitude M<sub>w</sub>: 7.33  
 Peak ground acceleration: 0.62  
 Depth to water table (insitu): 5.00 ft

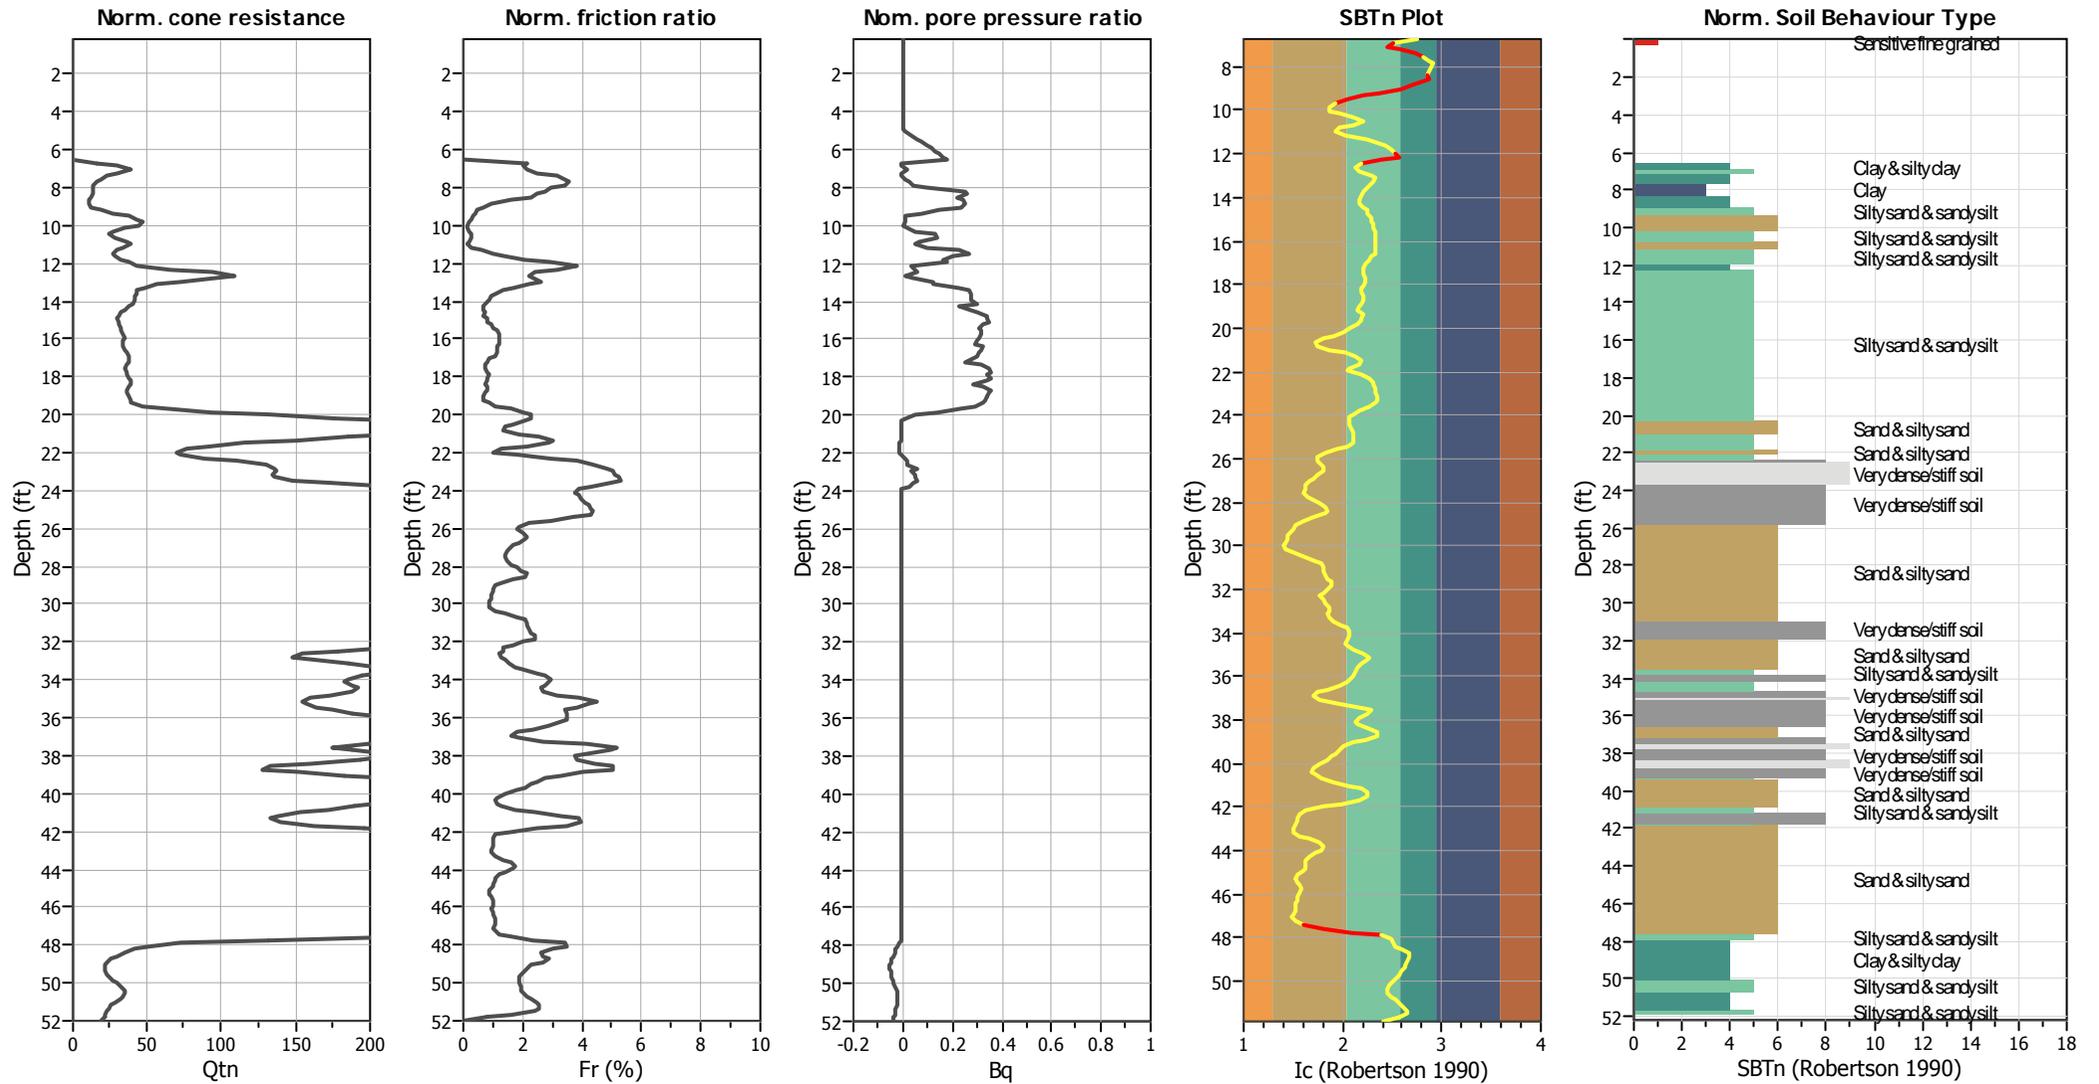
### CPT basic interpretation plots (normalized)

Analysis method:	I&B (2008)	Depth to GWT (erthq.):	5.00 ft	Fill weight:	N/A
Fines correction method:	I&B (2008)	Average results interval:	3	Transition detect. applied:	Yes
Points to test:	Based on Ic value	Ic cut-off value:	2.40	K <sub>q</sub> applied:	Yes
Earthquake magnitude M <sub>w</sub> :	7.33	Unit weight calculation:	Based on SBT	Clay like behavior applied:	Sand & Clay
Peak ground acceleration:	0.62	Use fill:	No	Limit depth applied:	No
Depth to water table (insitu):	5.00 ft	Fill height:	N/A	Limit depth:	N/A

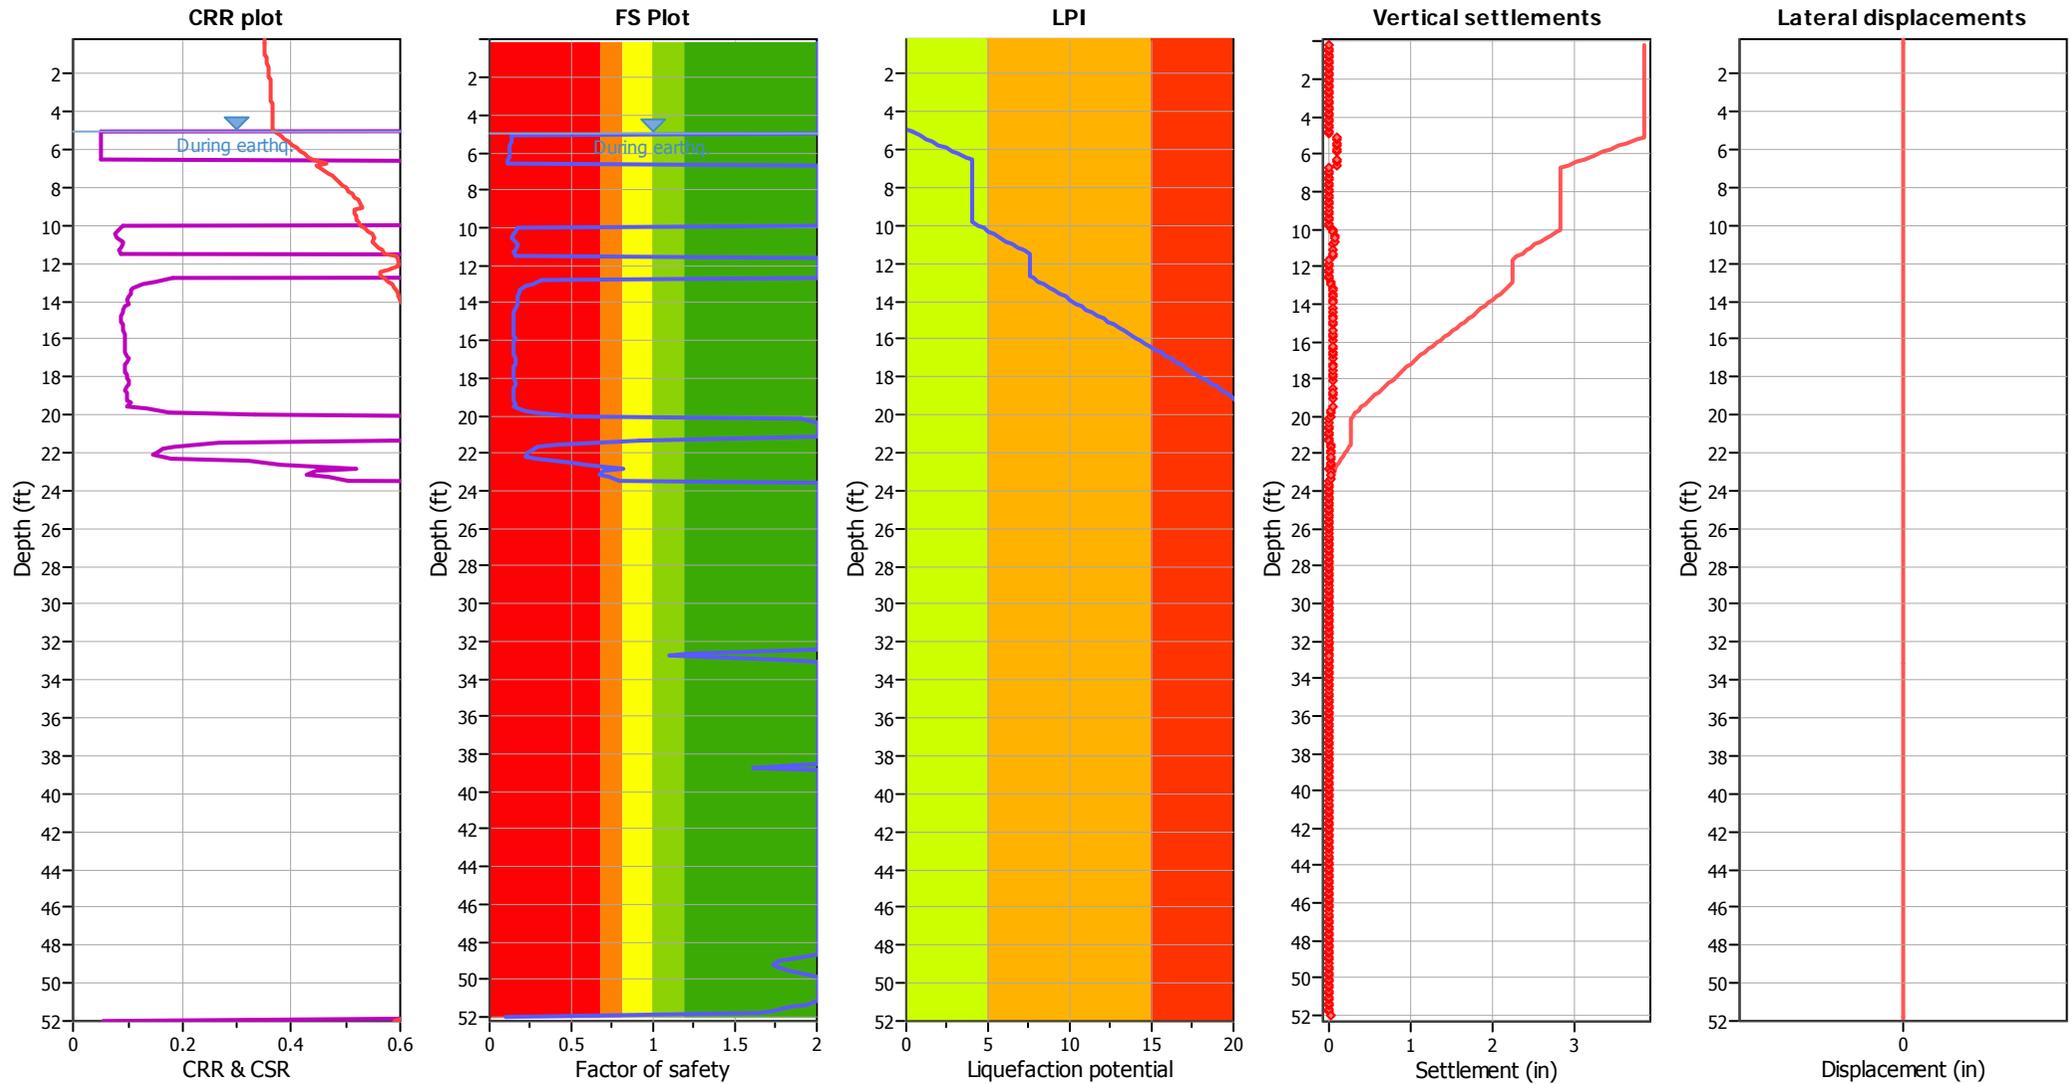
### Liquefaction analysis overall plots

Analysis method:	I&B (2008)	Depth to GWT (erthq.):	5.00 ft	Fill weight:	N/A
Fines correction method:	I&B (2008)	Average results interval:	3	Transition detect. applied:	Yes
Points to test:	Based on Ic value	Ic cut-off value:	2.40	$K_{\sigma}$ applied:	Yes
Earthquake magnitude $M_w$ :	7.33	Unit weight calculation:	Based on SBT	Clay like behavior applied:	Sand & Clay
Peak ground acceleration:	0.62	Use fill:	No	Limit depth applied:	No
Depth to water table (insitu):	5.00 ft	Fill height:	N/A	Limit depth:	N/A

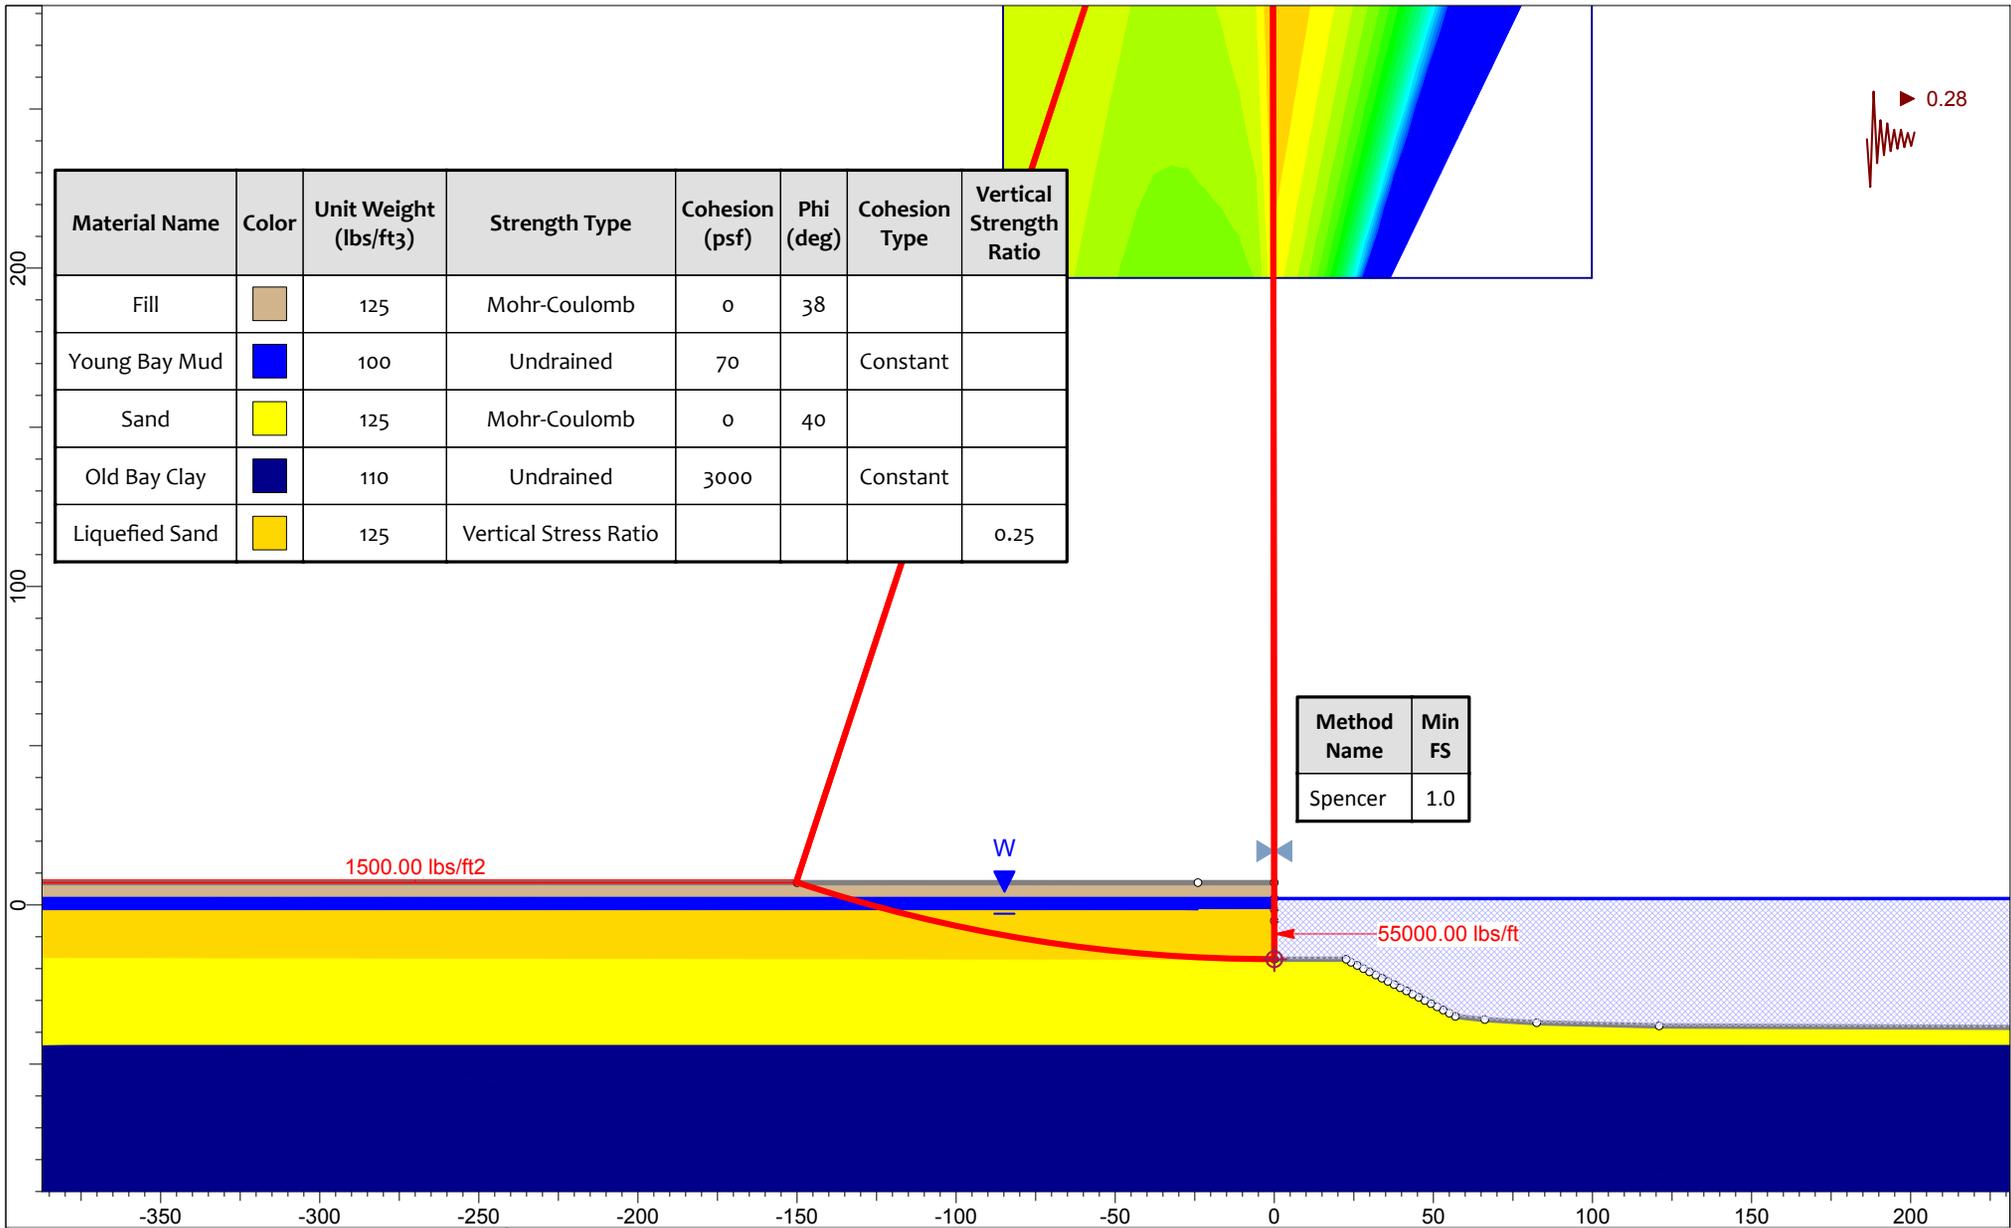
Project			Del Monte Warehouse		
	Analysis Description			Pseudo-Static		
	Drawn By	SOS	Scale	1:720	Company	ENGEO
	Date	04/20/2017		File Name	Bulkhead A-A' - DSM - Pseudo-Static force for wall.slim

We evaluated active pressures using the procedures shown in the National Cooperative Highway Research Program (NCHRP) Report 611, "Seismic Analysis and Design of Retaining Walls, Buried Structures, Slopes, and Embankments." We determined combined active and seismic loading using the GLE method (Section 7.4 of the NCHRP). In performing this analysis, we modified our previously performed slope stability analysis to include the subsurface conditions encountered in our recent CPTs. We also included an additional 1 foot of fill in our revised analysis to model the planed grade change based on discussions with you on December 9, 2016. To model the earthquake and earth pressure on the bulkhead, we removed all soil in our slope stability model on the passive side of the wall down to the bottom of the liquefied sand layer. We applied a horizontal boundary force at the location of the resultant force of active and dynamic earth pressures to determine the force that results in a factor of safety of 1 with a pseudostatic coefficient applied. We selected a pseudostatic coefficient of 0.28 based on an approximate displacement of 1 to 2 inches and the methodology in NCHRP 611 for estimating slope displacement. The pseudostatic coefficients are associated with the building code Maximum Considered Earthquake (MCE), as the critical failure surfaces extend below the adjacent warehouse and are related to liquefaction. We modeled the liquefied sand using a residual strength coefficient of critical strength divided by effective stress of 0.25 consistent with correlations by Stark and Mesri (1992). We assumed a horizontal load inclination neglecting friction between the wall and backfill. This force represents the total kinematic, static, and inertial earth load on the wall to achieve stability at the deformation amount assumed. The results of this analysis are shown in Appendix D.

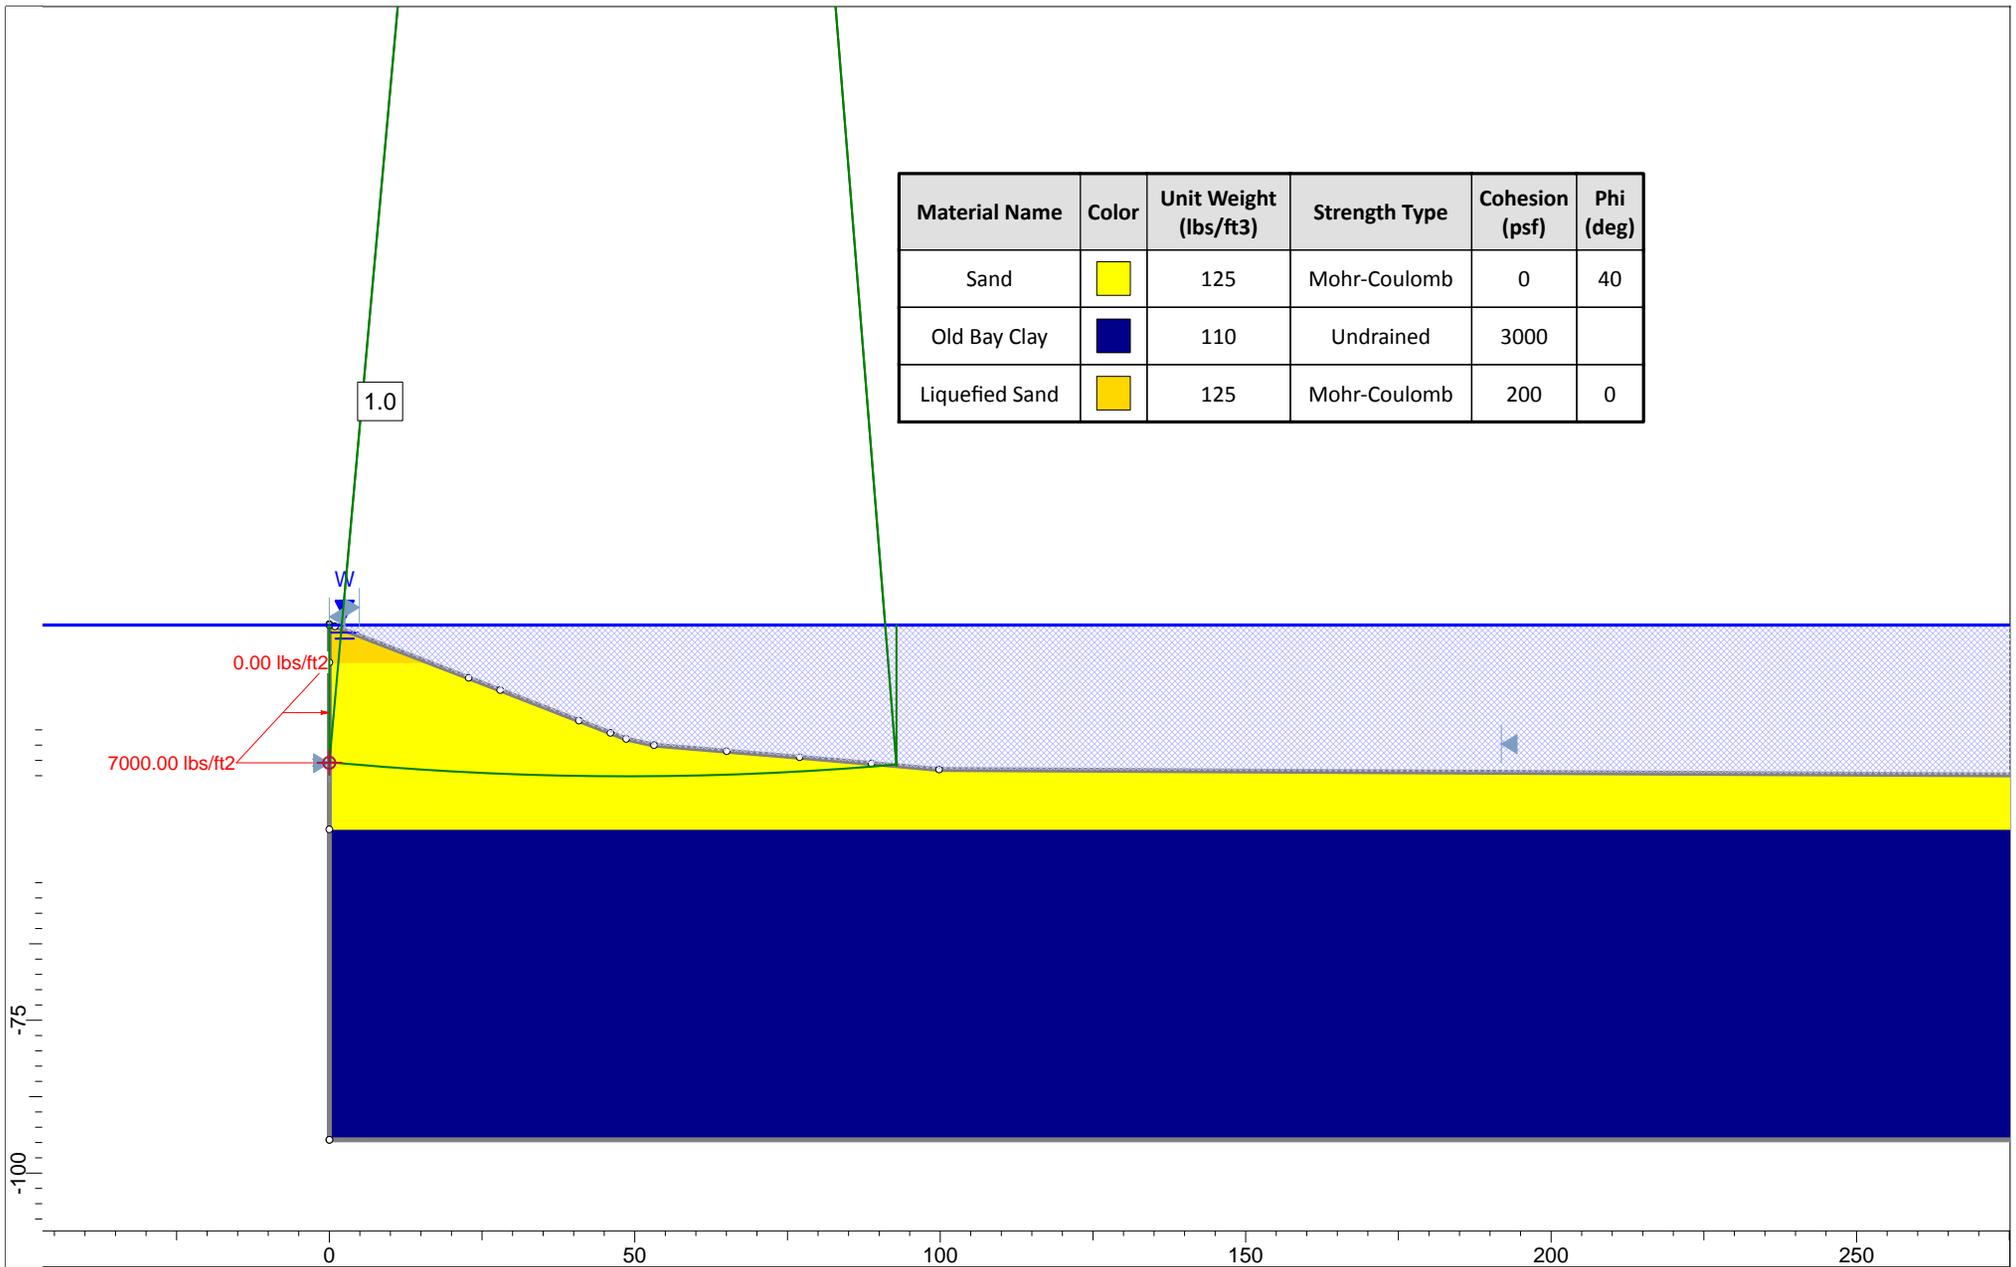
Project			Alaska Basin - Passive Pressures on Bulkhead - GLE Method		
Scale	1:375	Author	TMK	Project No.	9769.000.001
Date	December 1, 2016

Figure 4 graphically shows our recommended active, earthquake and passive pressures on the bulkhead for analysis. Based on coordination with the Marine Structural Engineer, Moffatt & Nichol, the pressures on the wall overstress the sheet piles and the anchors. Therefore, we recommend buttressing the liquefiable soil behind the bulkhead to reduce seismic loading on the structure as described in Section 3.3.
