**ALASKA BASIN BULKHEAD  
ALAMEDA, CALIFORNIA**

**SUPPLEMENTAL GEOTECHNICAL EXPLORATION**

December 6, 2016  
Revised November 15, 2018

9769.000.001

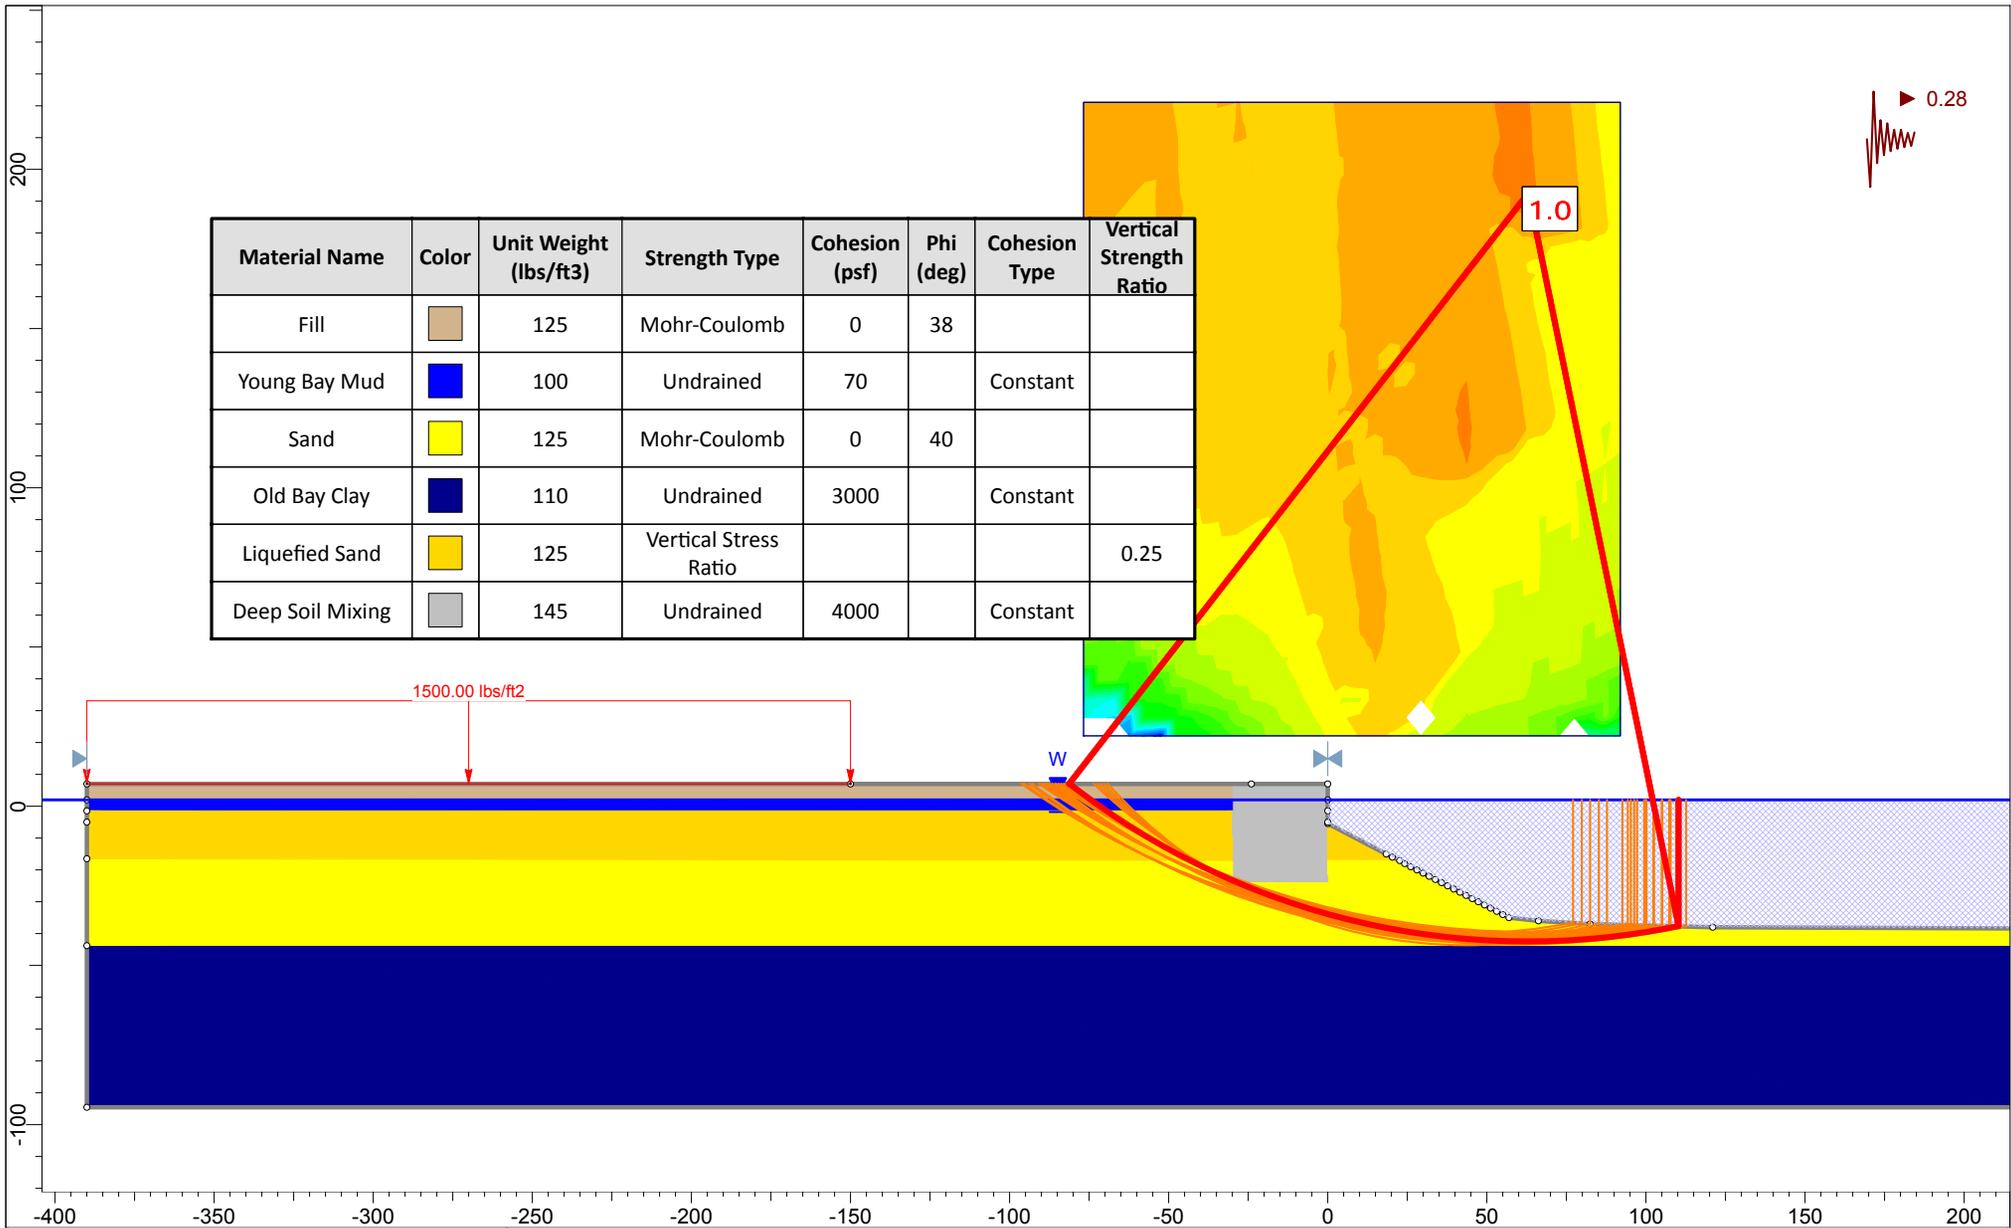
Material Name	Color	Unit Weight (lbs/ft3)	Strength Type	Cohesion (psf)	Phi (deg)	Cohesion Type	Vertical Strength Ratio
Fill		125	Mohr-Coulomb	0	38		
Young Bay Mud		100	Undrained	70		Constant	
Sand		125	Mohr-Coulomb	0	40		
Old Bay Clay		110	Undrained	3000		Constant	
Liquefied Sand		125	Vertical Stress Ratio				0.25
Deep Soil Mixing		145	Undrained	4000		Constant

Project		Del Monte Warehouse	
Analysis Description		Pseudo-Static	
Drawn By	SOS	Scale	1:720
Date	04/20/2017	Company	ENGEO
		File Name	Bulkhead A-A' - DSM - Pseudo-Static.slim

To evaluate the approximate minimum depth and lateral extent of this ground improvement method, we performed a slope stability analysis using the pseudo-static coefficient for 6 inches of deflection. In our analyses, we ignored the presence of the bulkhead and the tiebacks in stabilizing the soil (a conservative assumption). We modeled the DSM as a block assuming a compressive strength of 200 pounds per square inch (psi) which would result in a shear strength of about 100 psi, and a replacement ratio of 30 percent; we ignored the contribution to shear strength by the soil between the soil DSM columns to account for strain incompatibility and liquefied strengths. We then changed the dimensions of the DSM block until achieving at least a factor of safety of 1, which according to the NCHRP method referenced above, would result in a deformation of approximately 6 inches. Based on this analysis, the DSM should extend at least 30 feet back from the back face of the wall and extend to a minimum depth of 35 feet below existing grade.

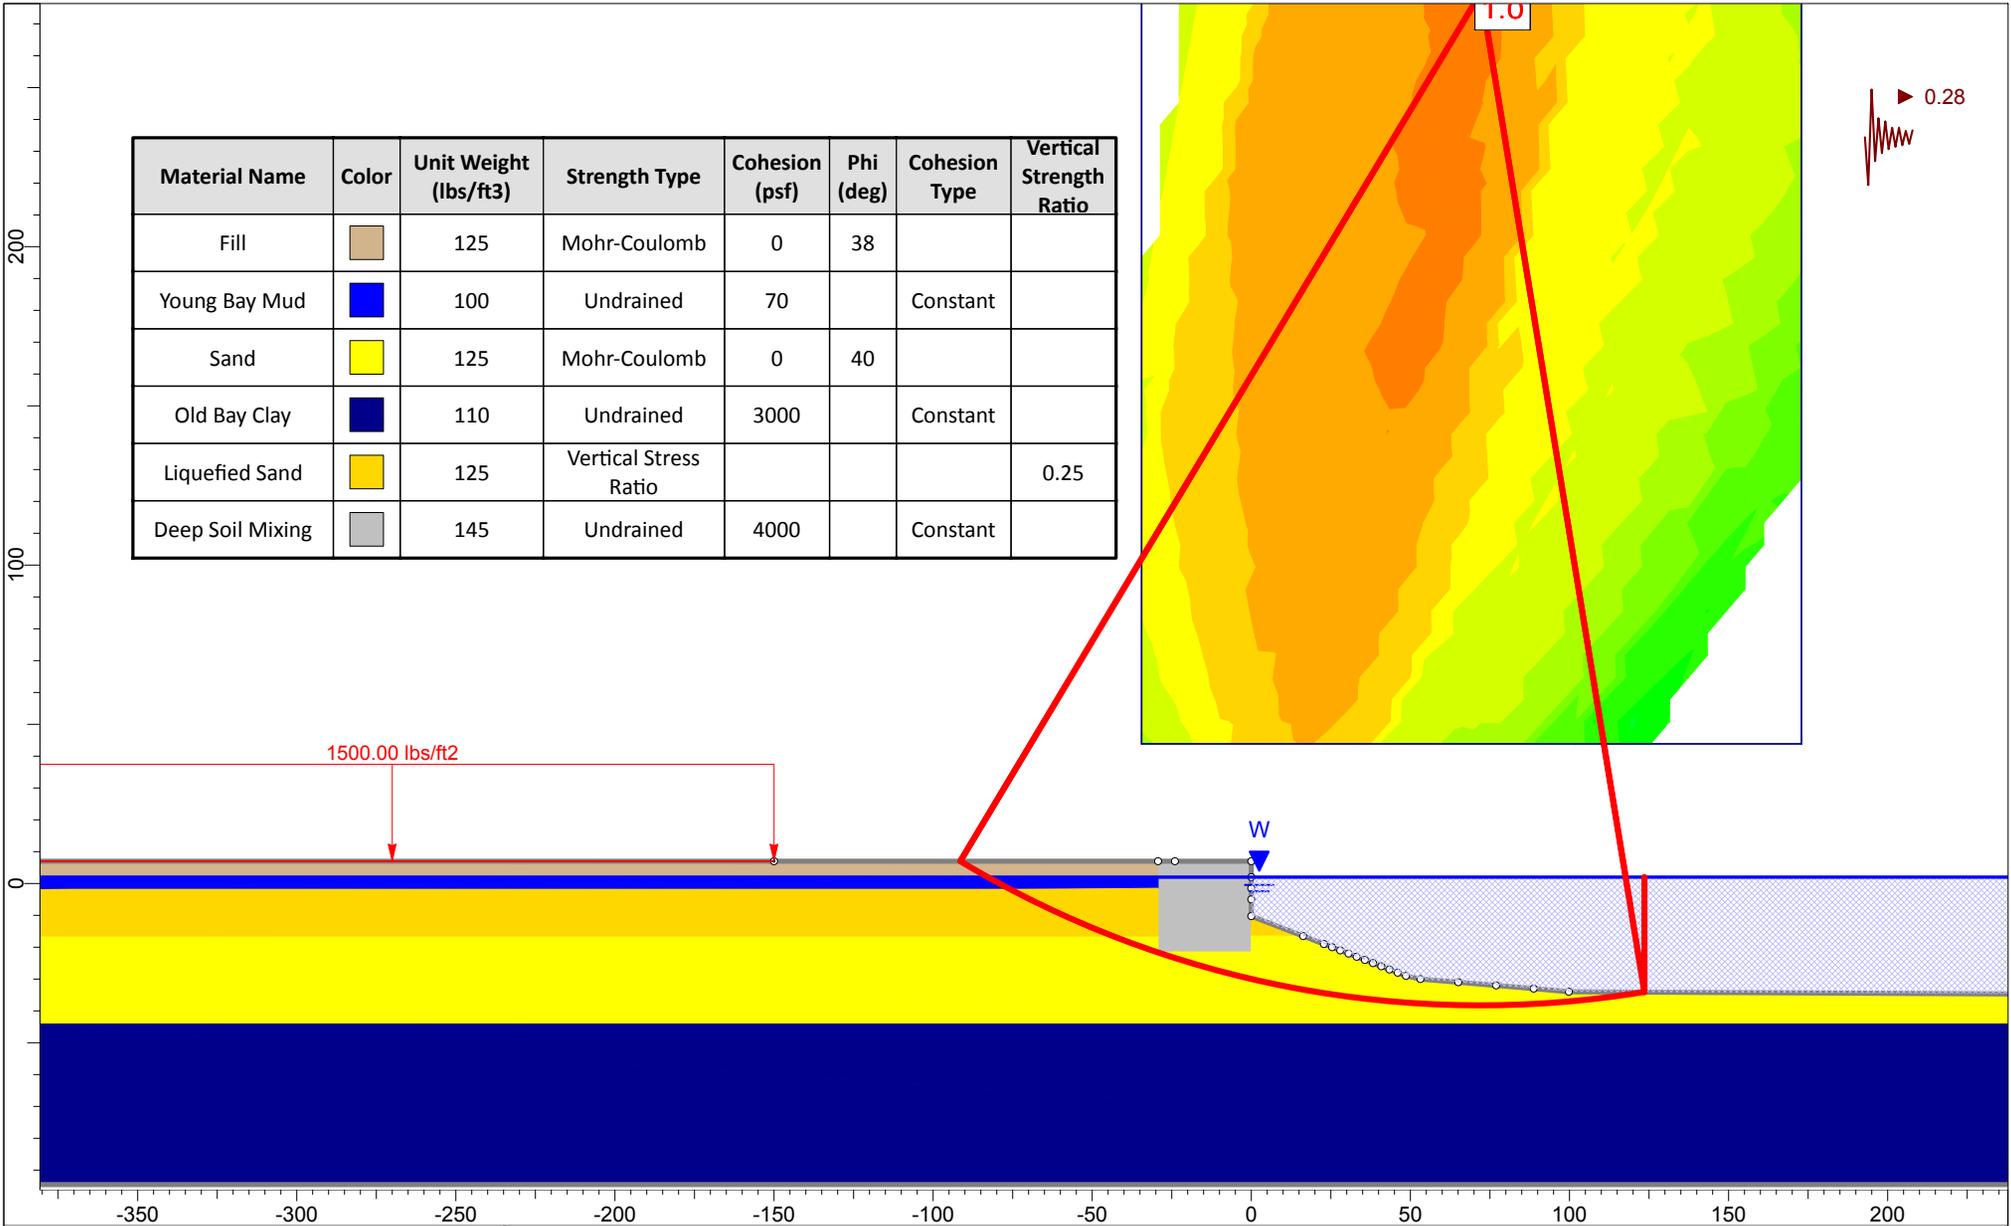
Project			Del Monte Warehouse		
	Analysis Description			Pseudo-Static		
	Drawn By	SOS	Scale	1:720	Company	ENGEO
	Date	04/20/2017		File Name	Bulkhead B-B" - DSM - Pseudo-Static.slim
