NORTH WATERFRONT COVE LLC

We write to respond to questions raised by the Engineering Criteria Review Board of the BCDC in a meeting on January 24, 2019 related to the seismic safety of the Northern Wharf Structure at the proposed Encinal Terminals Development in Alameda, California.

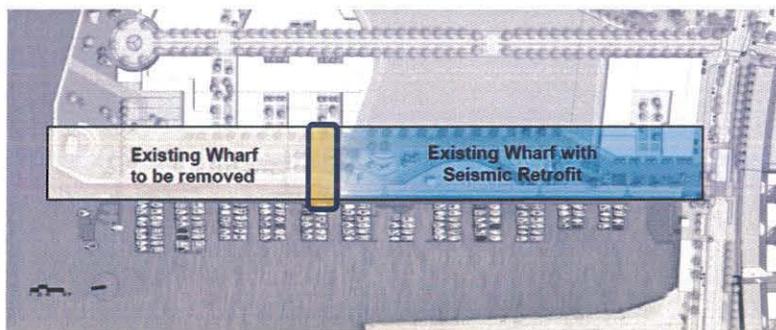
The Northern wharf will ultimately be demolished, at approximately Station 10+00 (shown below in orange). Total Northern concrete wharf demolition in this area is approximately 70,000 s.f. Station 10+00 was selected because it is the area where ENGEO has safely determined that the Young Bay Mud horizon is less than 40', and where the retrofit scheme can be utilized. If there is a period of time when the southern portion of the retrofitted wharf has been completed
