## Lee Shore Hazard at the Proposed Berkeley Ferry Dock

The proposed location of Berkeley's WETA Ferry Dock is in a normally very windy area where a loss of control or propulsion could result in a ferry running aground or hitting the Skates restaurant.

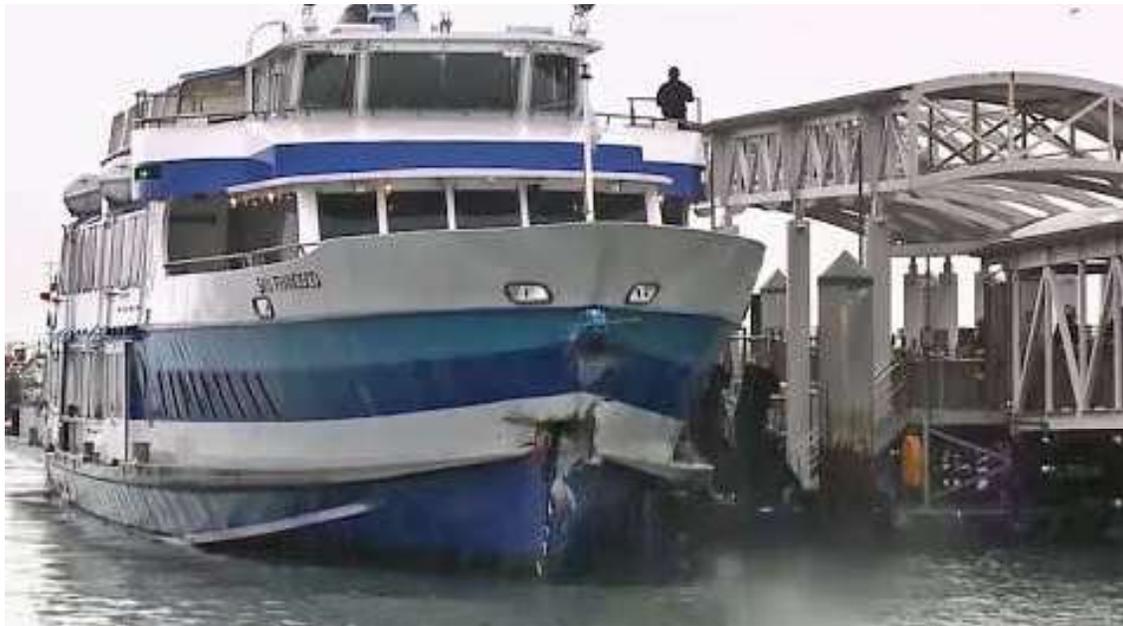
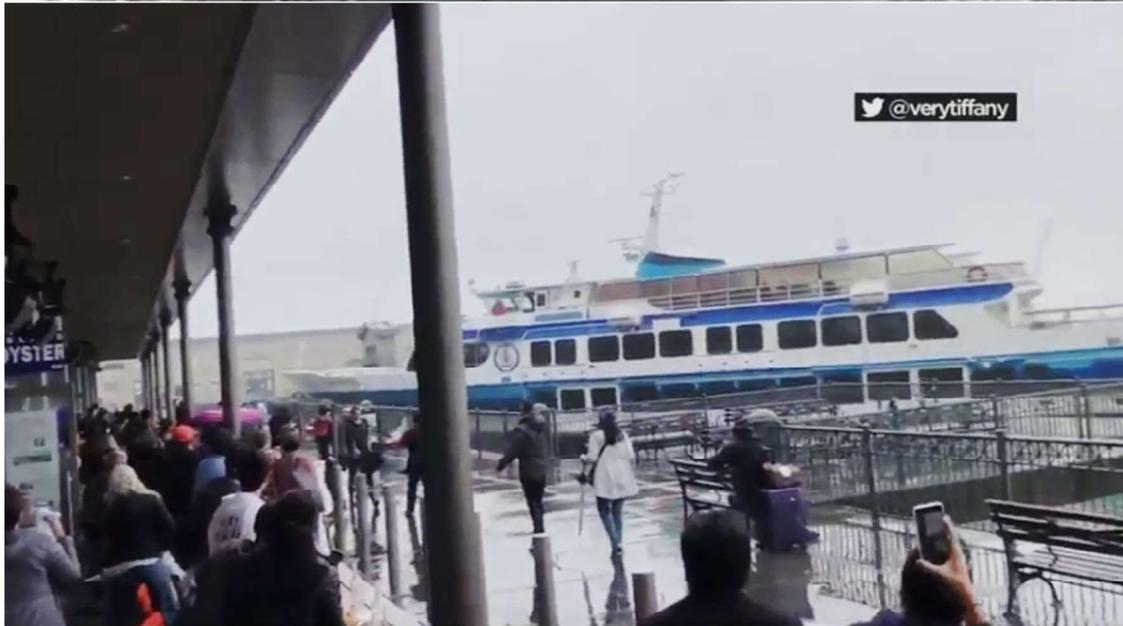
On November 23, 2018 a Golden Gate Ferry rammed a dock at the San Francisco Ferry building, check out the bow damage in the picture above and this [video](#). Fortunately, there were no serious injuries and damage was relatively minor. The [cause](#) of the accident appears to have been the captain's unfamiliarity with a recently upgraded control system.

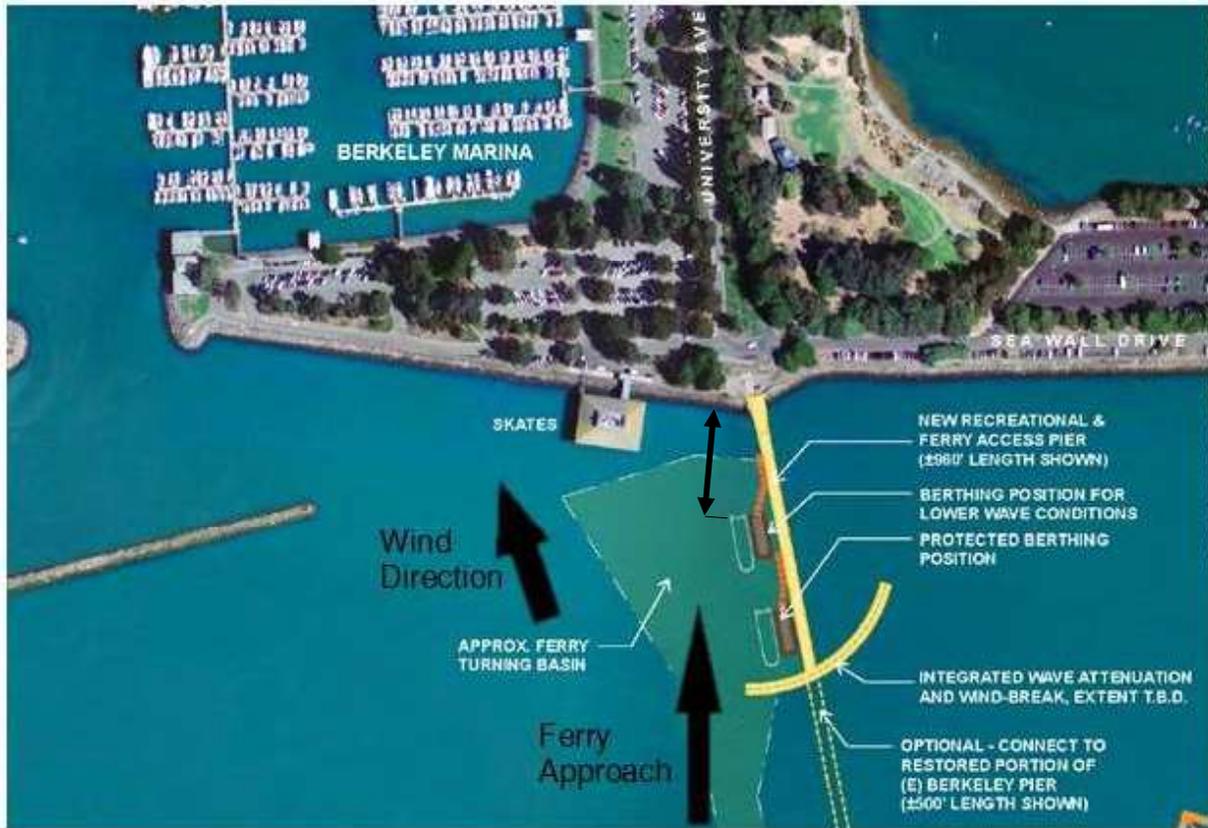
FINAL\_Ferry Terminal Facility Feasibility Study - Berkeley Municipal Pier

Consider the possibility of a loss of control incident occurring in a ferry approaching the dock proposed for the Berkeley WETA ferry (see below). An inbound ferry will normally arrive downwind roughly along the “Ferry Approach” arrow, then make a 180° turn in the “Ferry Turning Basin” so the ferry ends up pointed upwind when it arrives at the dock. The summer afternoon winds are often well above 20 mph, the chop is significant, and most of the marina’s boat traffic leaves and arrives through this area. The 180° turn and docking will be demanding even with perfectly functioning equipment.

See Page 34 (arrows added)

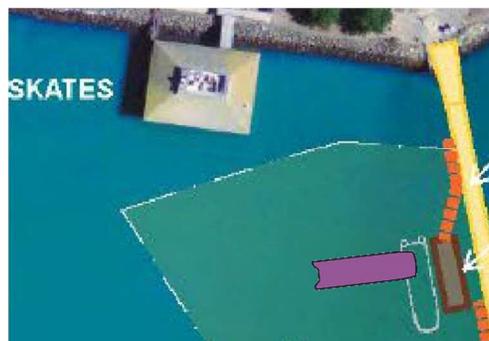
Zoomed-in image showing Dorado-sized (~300 passenger) ferry halfway through a 180° turn.

This is a very tight situation in which to suffer a control or propulsion loss. The inshore end of the ferry’s dock is only 200 feet upwind of the rocky shore, and a 20- or 25-mph wind would soon push a disabled ferry downwind onto the rocks or the Skates restaurant. Skates is built on

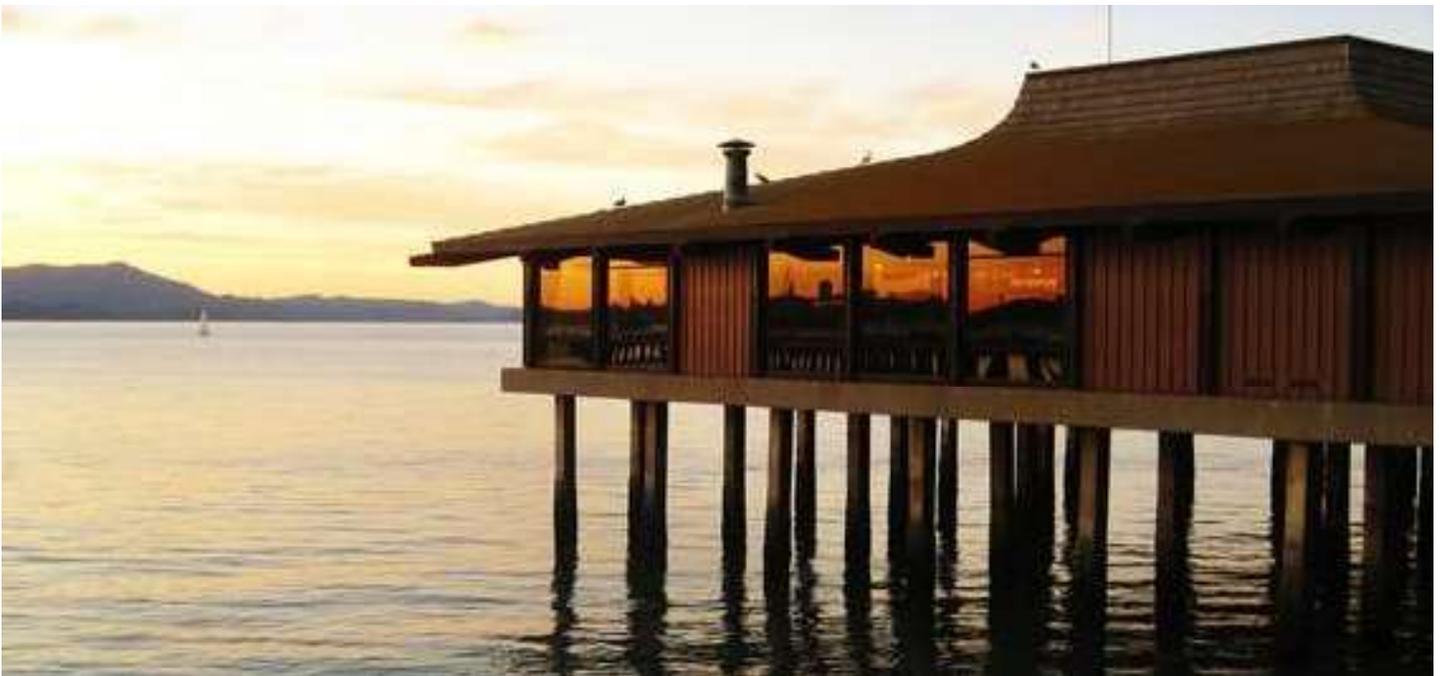
**Skates Restaurant**      Would Skates survive being hit by a 135-foot, 169-ton ferry?

tall, slender pilings (see next page) and might not survive wind and waves pushing a 135-foot-long ferry against and perhaps underneath it. Injuries and damage in such an accident would be very likely.
