Hill Slough Tidal Marsh Restoration Project

San Francisco Bay Conservation and Development Commission
Meeting

September 7, 2017

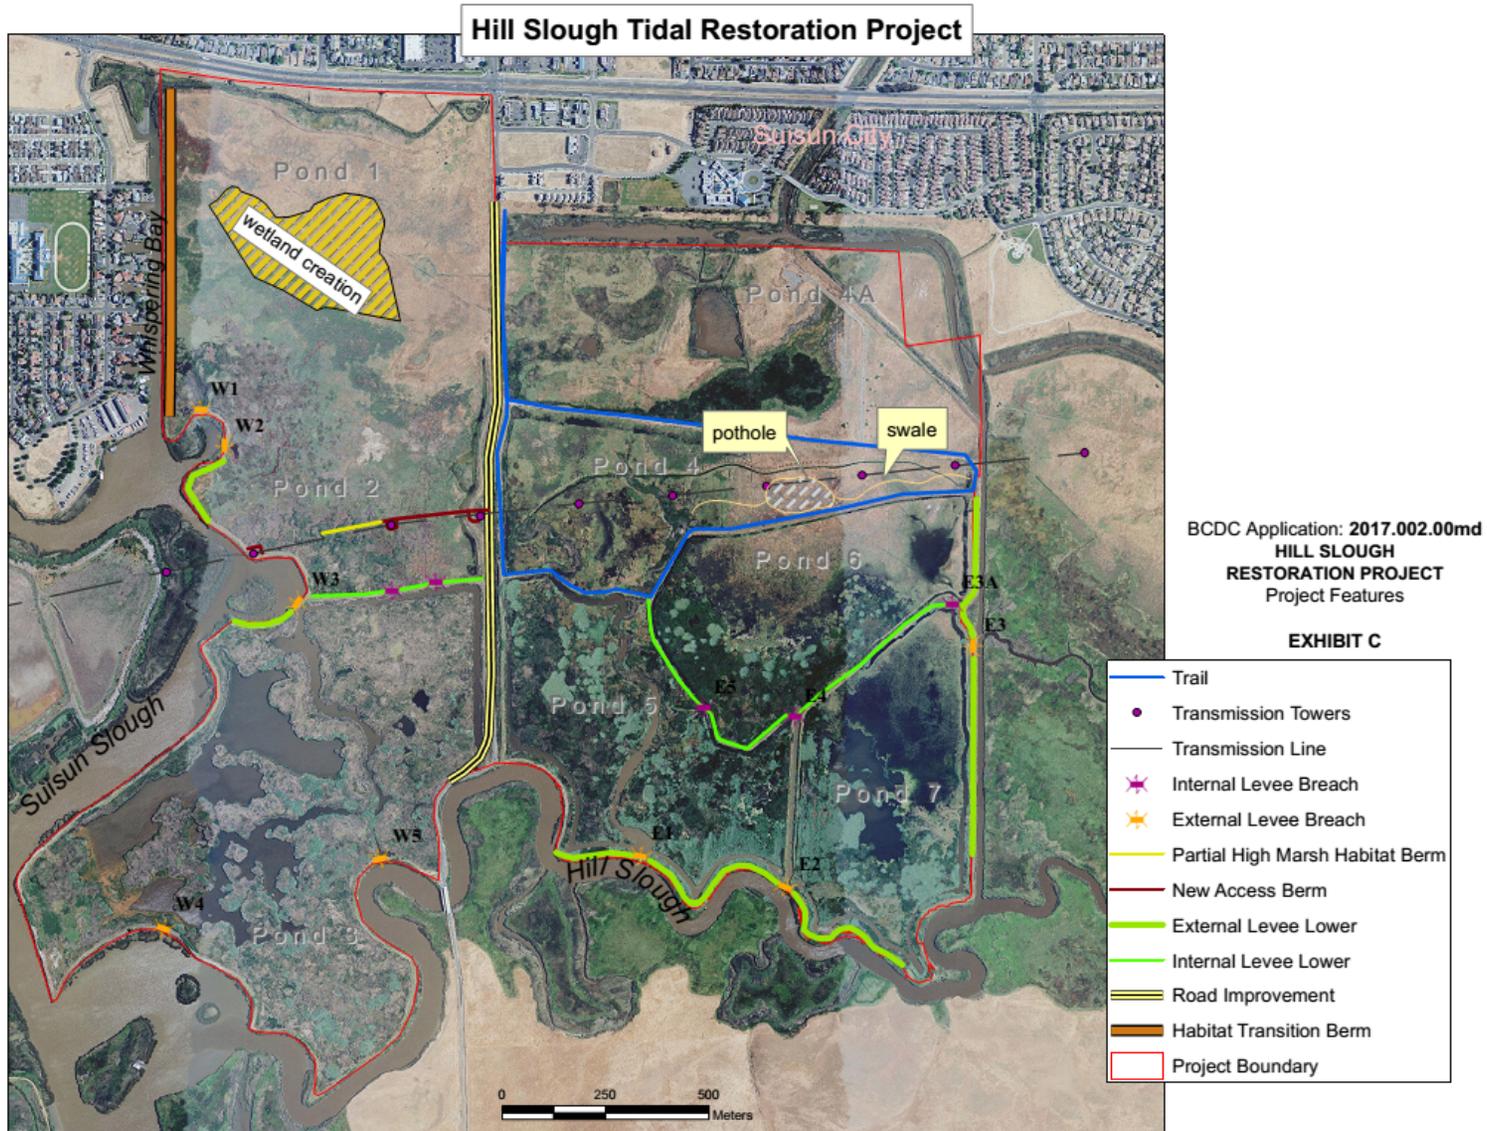
Project Design

- Raise the elevation of Grizzly Island Road and add Class II bicycle lanes
- Create a berm to protect PG&E facilities
- Construct two miles of trail
- Lower some levees and raise others
- Breach levees along Hill and Suisun Sloughs, and McCoy Creek
- Add, remove, abandon culverts

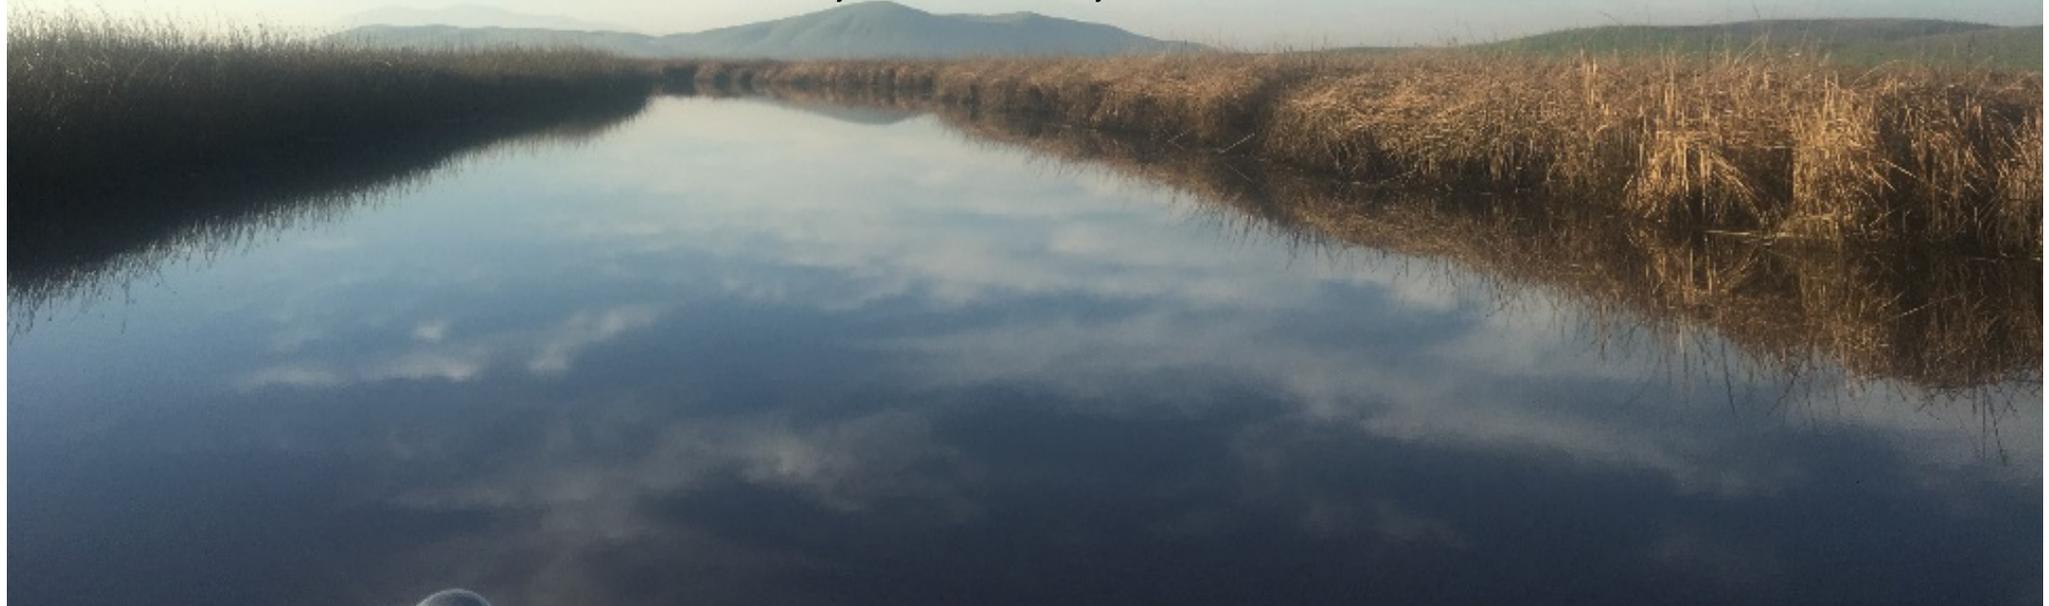
Expected Habitats

- 192 acres mixed wetland complex
- 640 acres tidal marsh and upland
 - 53 acres upland
 - 19 acres high marsh
 - 18 acres mid marsh
 - 110 acres low marsh
 - 440 acres marsh, mudflat, subtidal

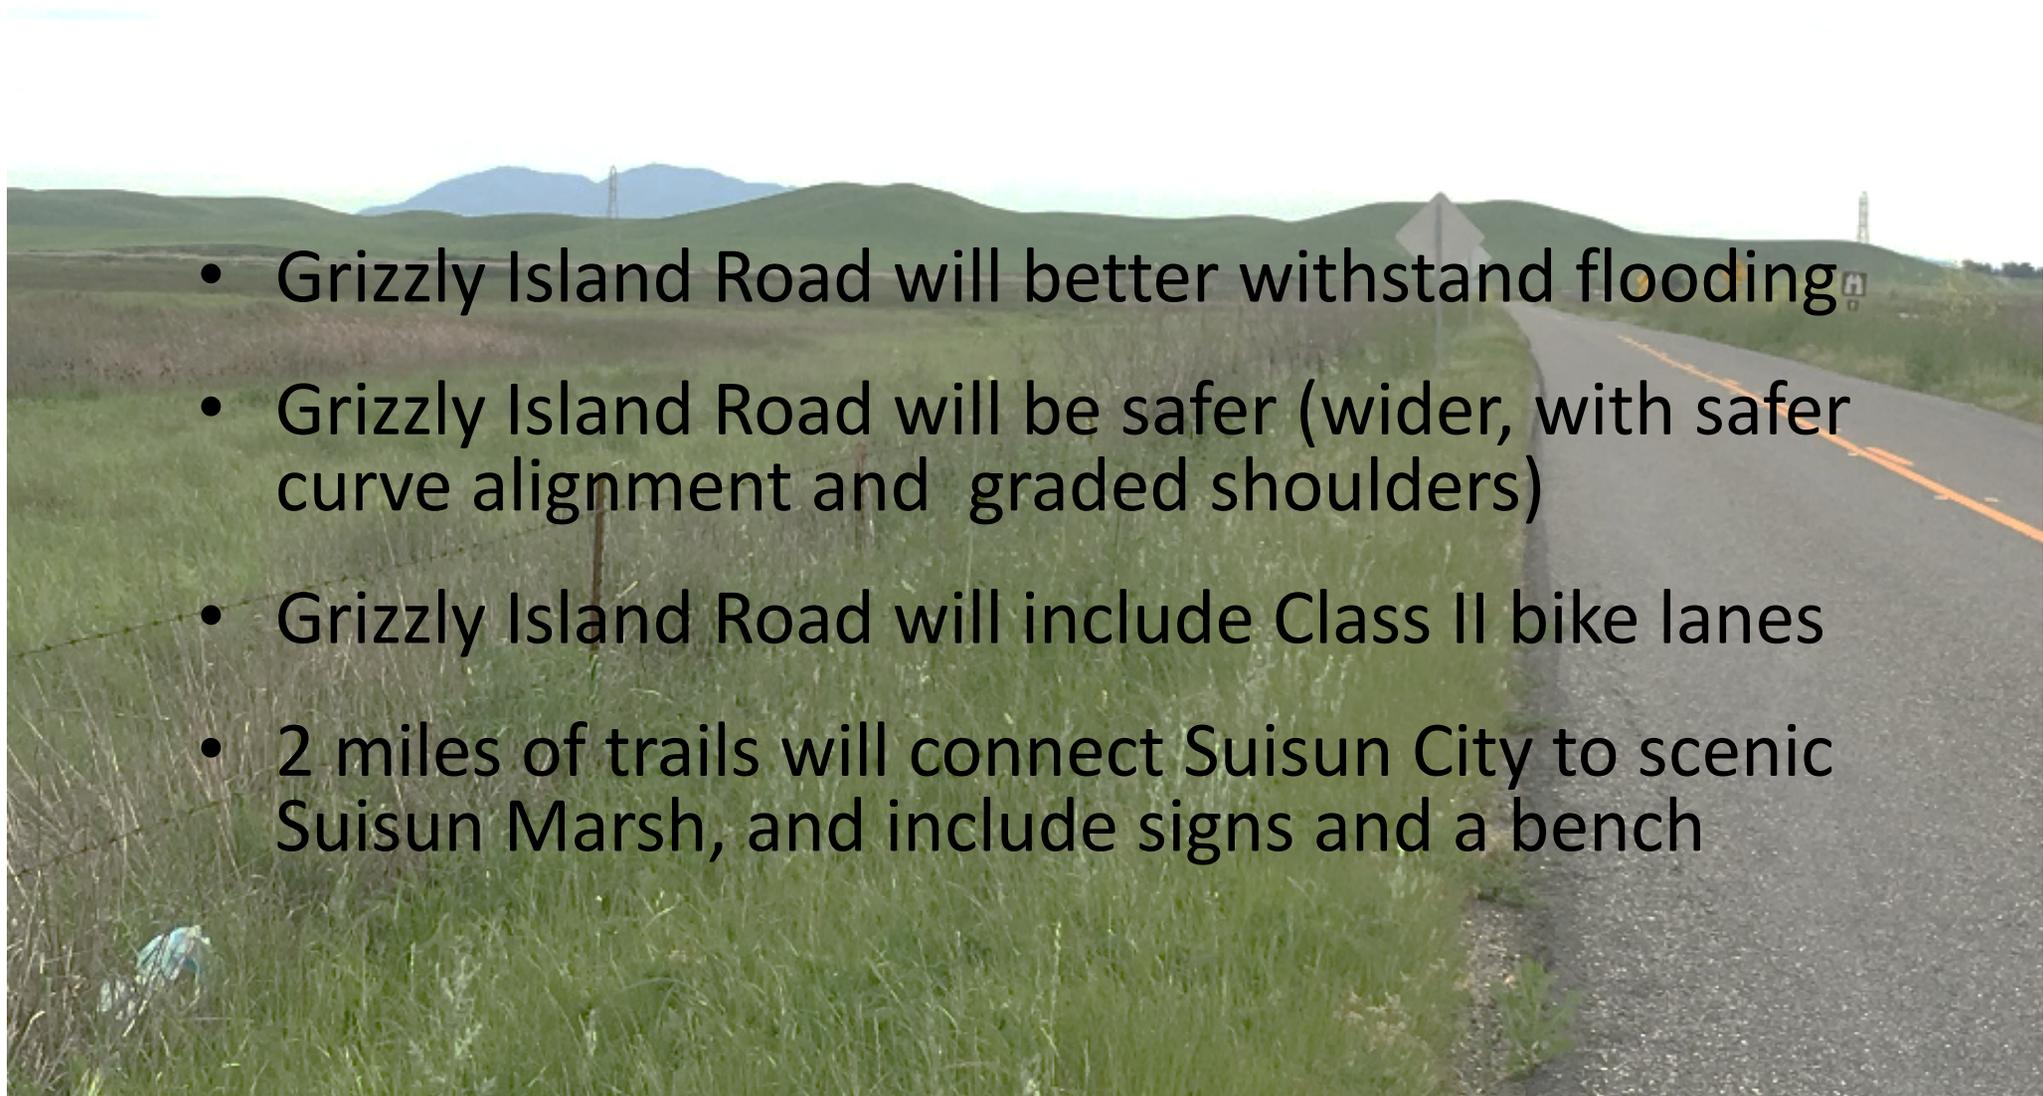
New/Improved Public Access

- Grizzly Island Road will better withstand flooding
- Grizzly Island Road will be safer (wider, with safer curve alignment and graded shoulders)
- Grizzly Island Road will include Class II bike lanes
- 2 miles of trails will connect Suisun City to scenic Suisun Marsh, and include signs and a bench
